UMTRI-83-3

Biomechanical Accident  
Investigation Methodology

Final Report  
February 1983

Prepared for  
Motor Vehicle Manufacturers Association  
320 New Center Building  
Detroit, Michigan 48202

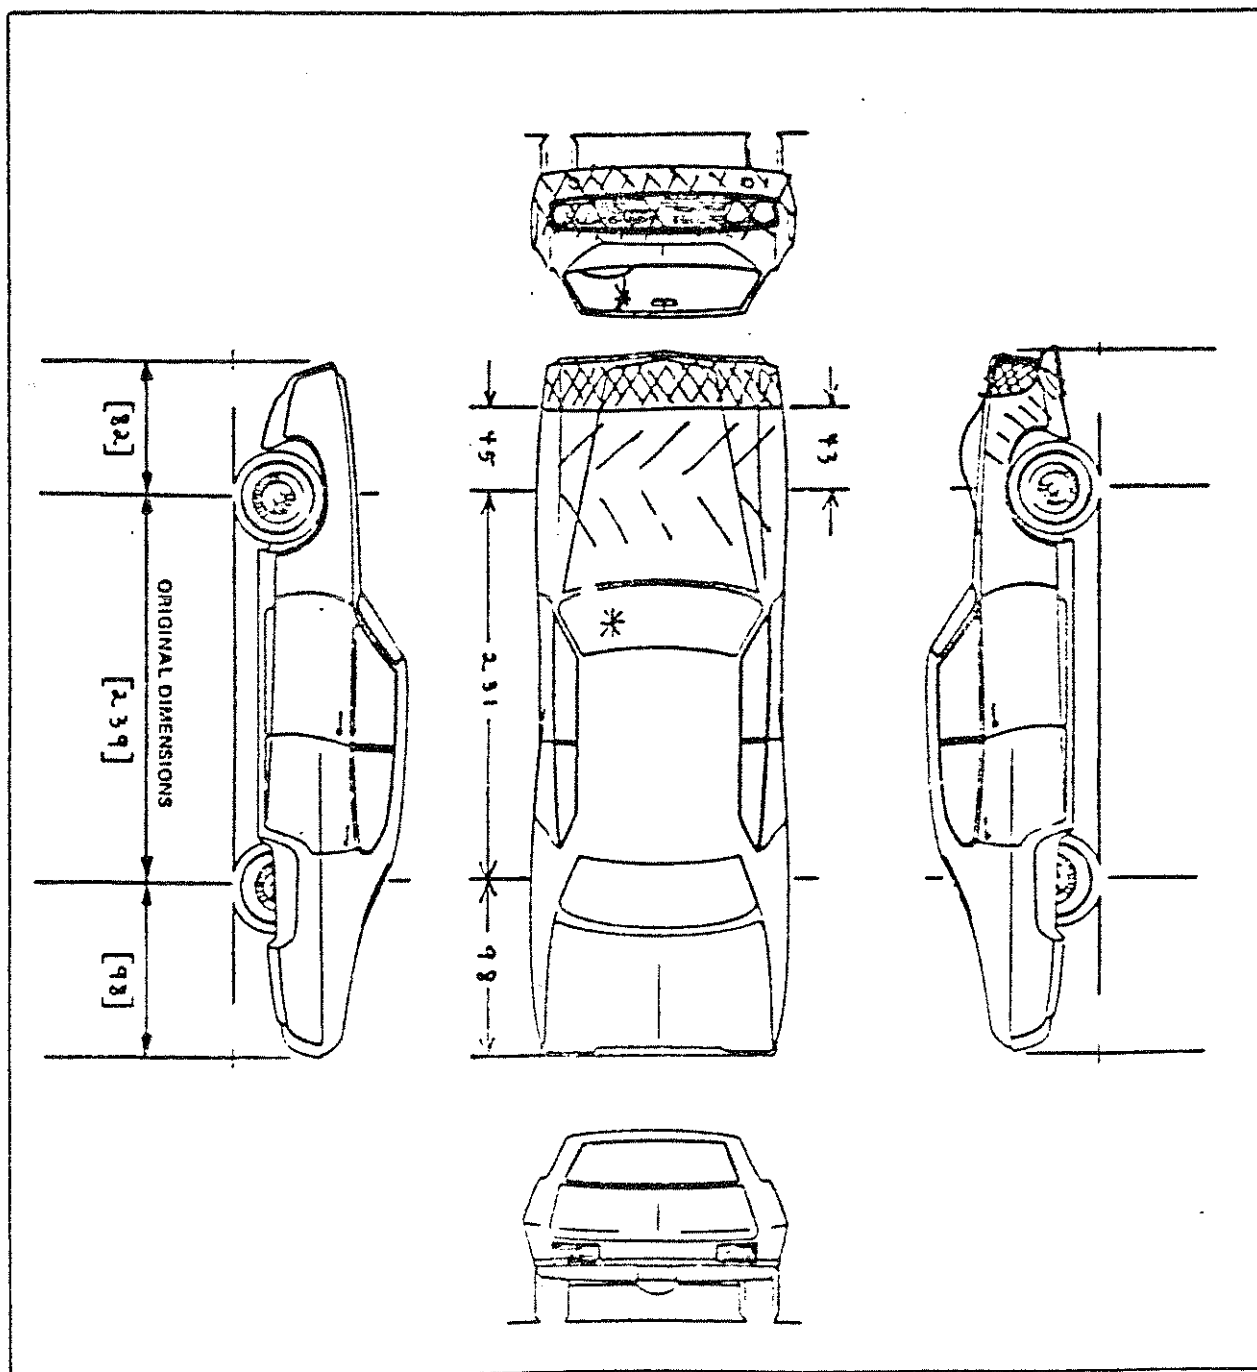
Figure 2. Vehicle Damage (Case No. 9).

In this case a 1981 Mercury Lynx driven by a 35 year old male was driving on a freeway when it struck the rear of a 1972 Chevrolet Nova which was stopped on the paved right shoulder of the roadway. Figure 1 is a schematic of the accident scene showing the square rear-end impact as well as the well-defined resting points of the vehicles. Figure 2 shows the damage to the front end of the Lynx.

Interior damage to the vehicle was moderate. Driver contact deformed the left sunvisor and contiguous windshield header. After the windshield was starred, continued head travel caused a jagged tear in the laminate of about 20 cm (7.87 in) and an outward bulge of 4 cm (1.57 in). Chest contact with the steering wheel caused it to fold around the hub and forward nearly to the instrument cluster eyebrow. The vehicle steering column was configured to include a V-joint flexible coupling and the right shear capsule was separated about 35 mm (1.38 in). Also, there was obvious upward rotation and lateral right movement of the column. Although they did not appear to be damaged, the driver may have had his left hand between the steering wheel rim and the two control levers on the left of the steering column or the left side of the instrument cluster eyebrow. The left end of the lower panel below the headlight switch was deformed by the driver's

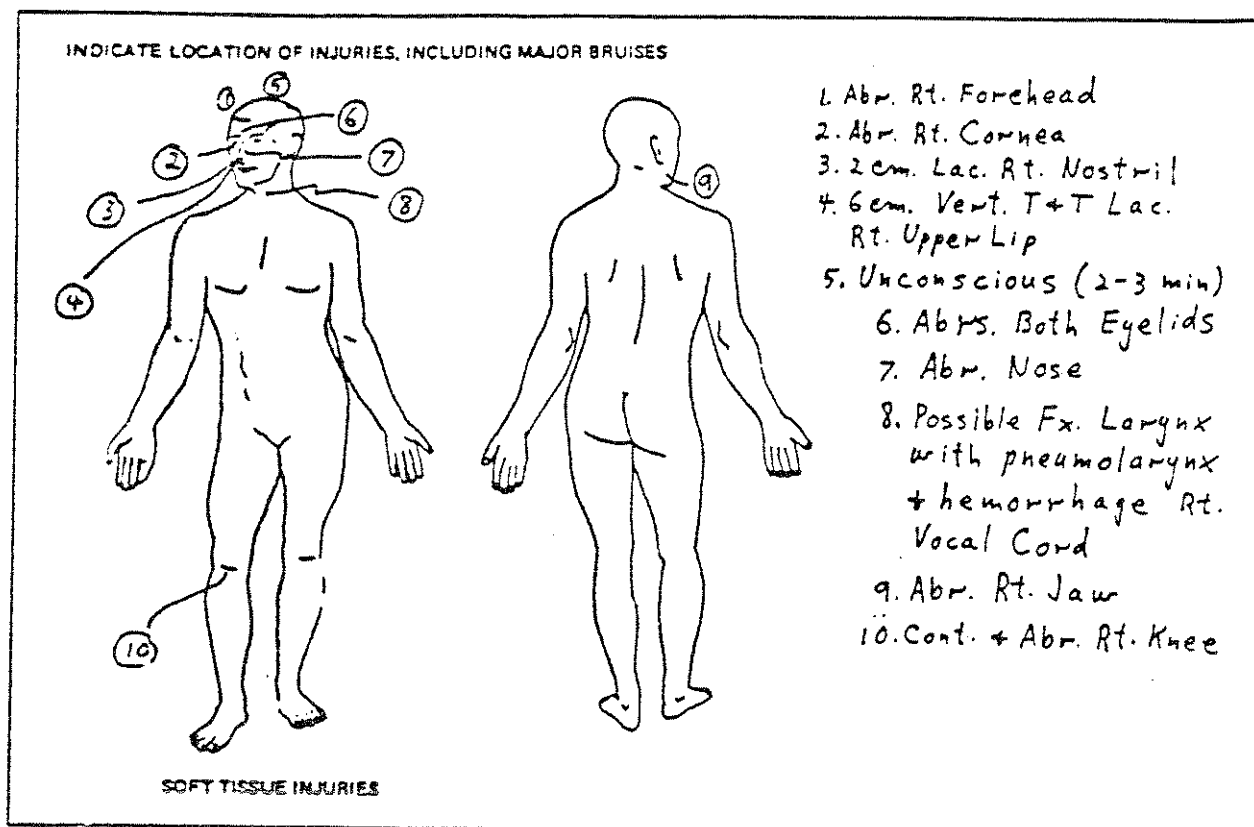
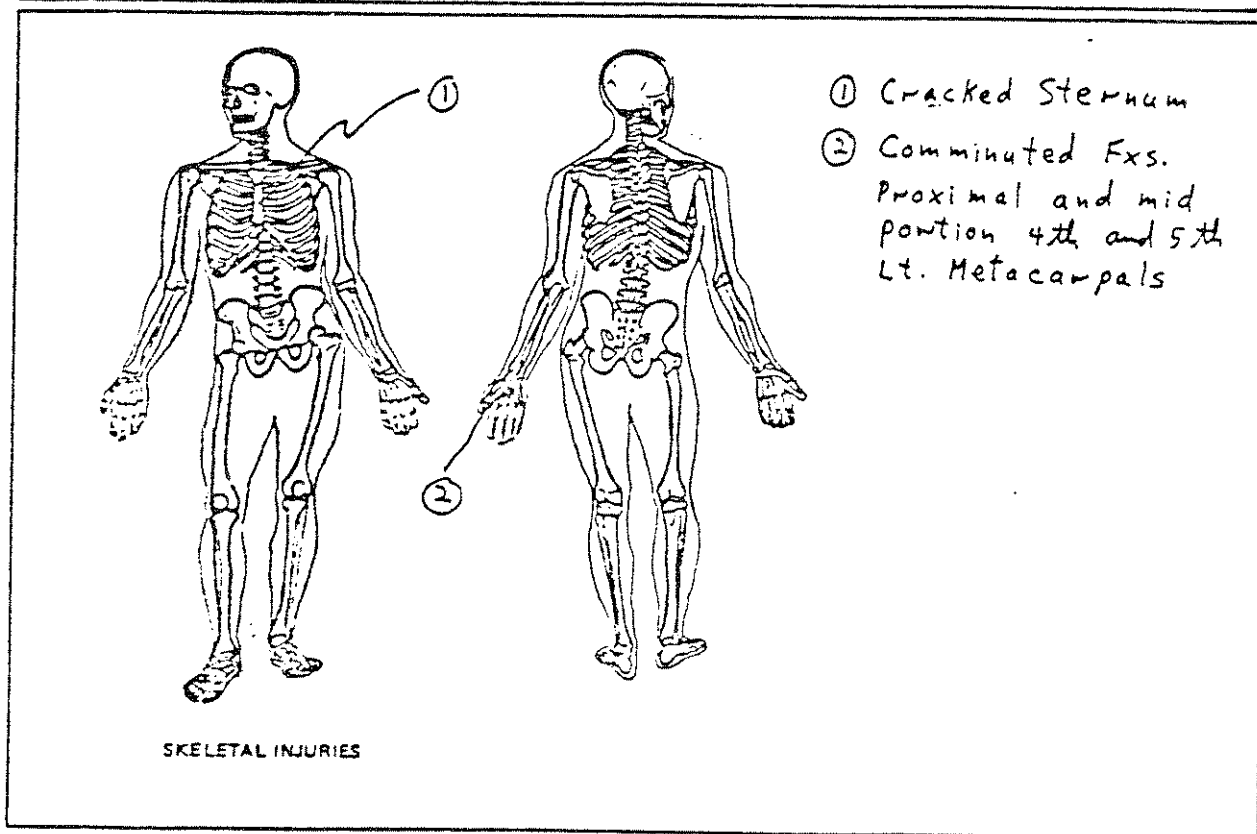
Figure 3. Occupant Injuries (Case No. 9).

The lone male driver was unrestrained and upon impact is estimated to have continued forward and struck the left sunvisor and header with his forehead, the windshield with his face, the steering wheel with his throat and chest, and the lower panel with his knees.

This large, 35 year old male sustained significant head impacts against the header and windshield. The force levels of 1800-1900 lbs. associated with these impacts would not be expected to cause frontal bone skull fractures although they approach the lower limits of frontal fracture tolerance for flat impact surfaces. Similarly, the head accelerations associated with these two impacts are moderately severe (peaks near 120 G's). Additional head acceleration peaks around 80 G's are also present, and the entire head acceleration-time history (Figure 15) is characterized by significant time durations as well as acceleration magnitudes. This subject was concussed for 2-3 minutes.

The size and position of the subject and the vehicle interior geometry combined to produce a uniform contact of the chest squarely with the steering wheel. Although uniform, the loading was severe enough to fracture the sternum. The predicted load peak was approximately 2000 lbs. which is similar in magnitude to those produced by experimental studies on chest impact with cadavers. The chest accelerations associated with the impact were less than 50 G.

The contact of the subject's legs with the instrument panel produced an average force of 1300 lbs. in each femur and 1000 lbs. into each lower leg. This resulted in a total femur load of approximately 2300 lbs. in each leg as the lower leg force would be transmitted by shear to the upper leg. The lower leg load was close to tolerable values for knee joint ligamentous damage in cadavers. The subject was tall and had robust legs. Neither the average lower leg loads of 1000 lbs. nor the total femur loads of 2300 lbs. were likely near the tolerance of this subject.

The most severe injury sustained by the subject was a possible fractured larynx which has an AIS rating of 4. However, the forces and ac-

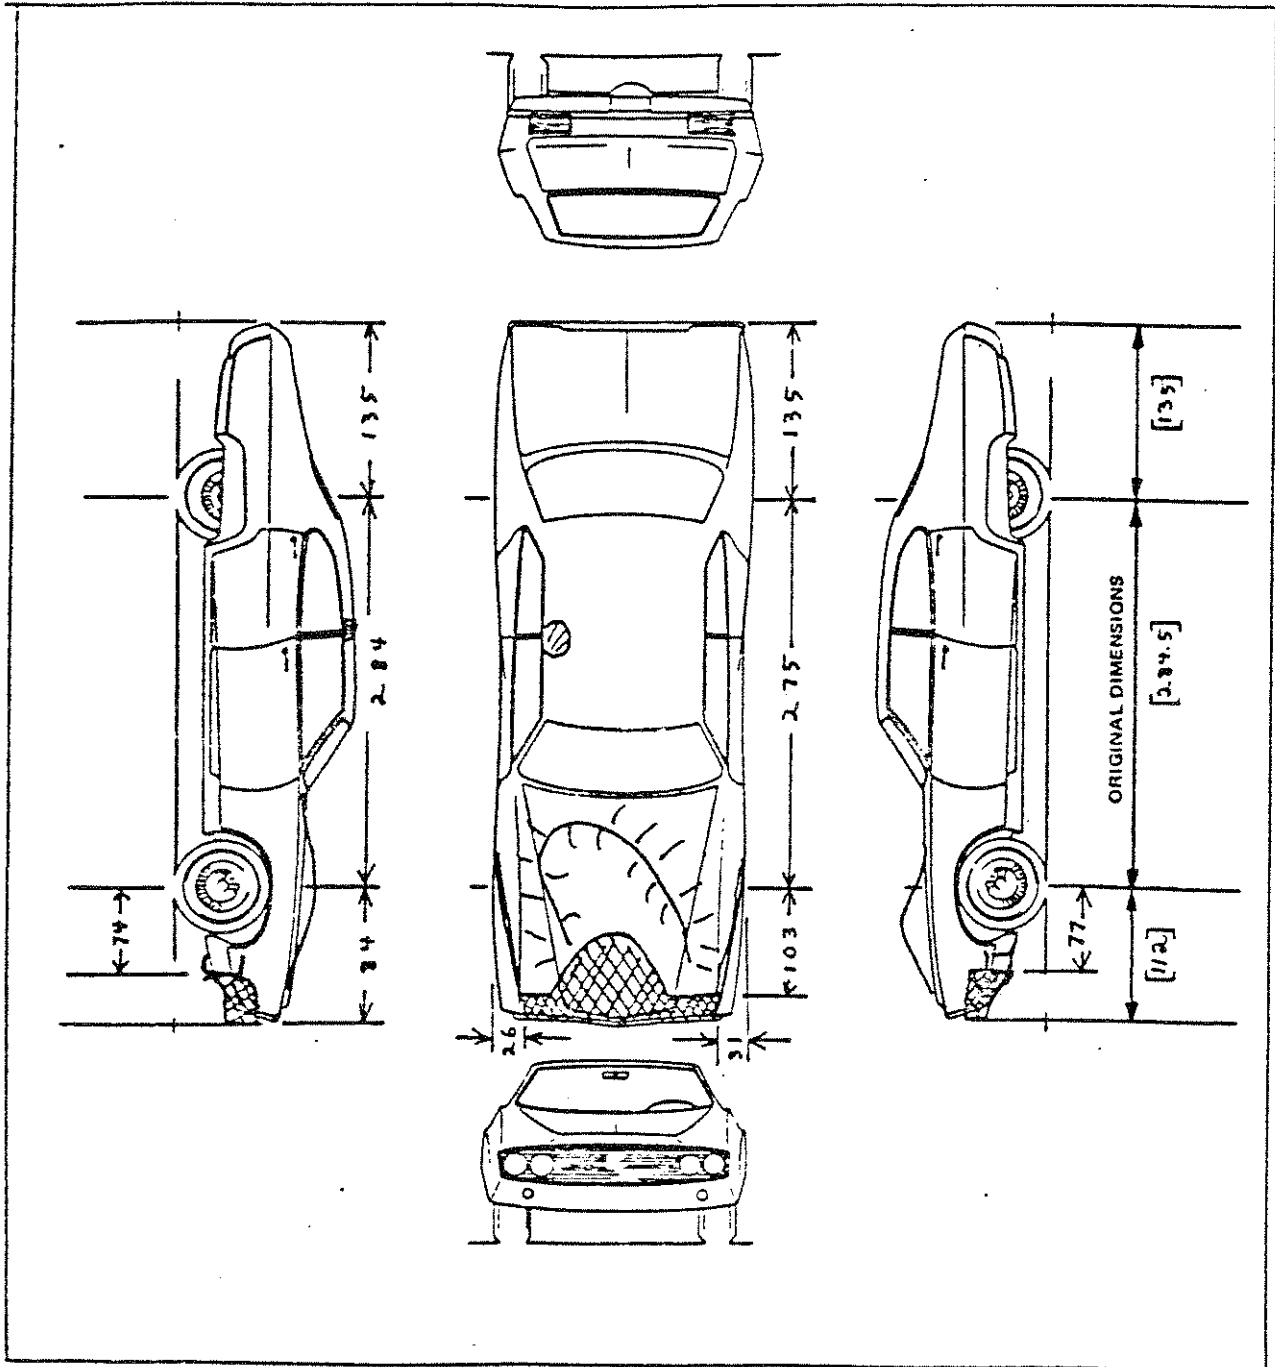
Figure 17. Vehicle Damage (Case No. 10).

In this case a 1977 Oldsmobile Cutlass S was forced off the roadway and struck a 56 cm diameter tree directly head-on. Frontal crush of the car was 93 cm. Figure 16 is a schematic of the accident showing the well-defined vehicle motions. Figure 17 shows the severe and almost perfectly symmetric damage sustained by the vehicle.

Interior damage to the vehicle was moderately heavy. The left sunvisor and header were damaged and the windshield was starred by the driver. The lower half of the steering wheel rim was severely bent and the spokes were slightly deformed. This caused the energy absorbing device to be compressed about 123 mm (4.84 in) and the shear capsules were separated. Upward force by the driver caused the steering column to rotate upward, but separation of the shear capsules necessitated its final state to be down. Driver contact broke the mid and lower panel areas to both the left and right of the column.

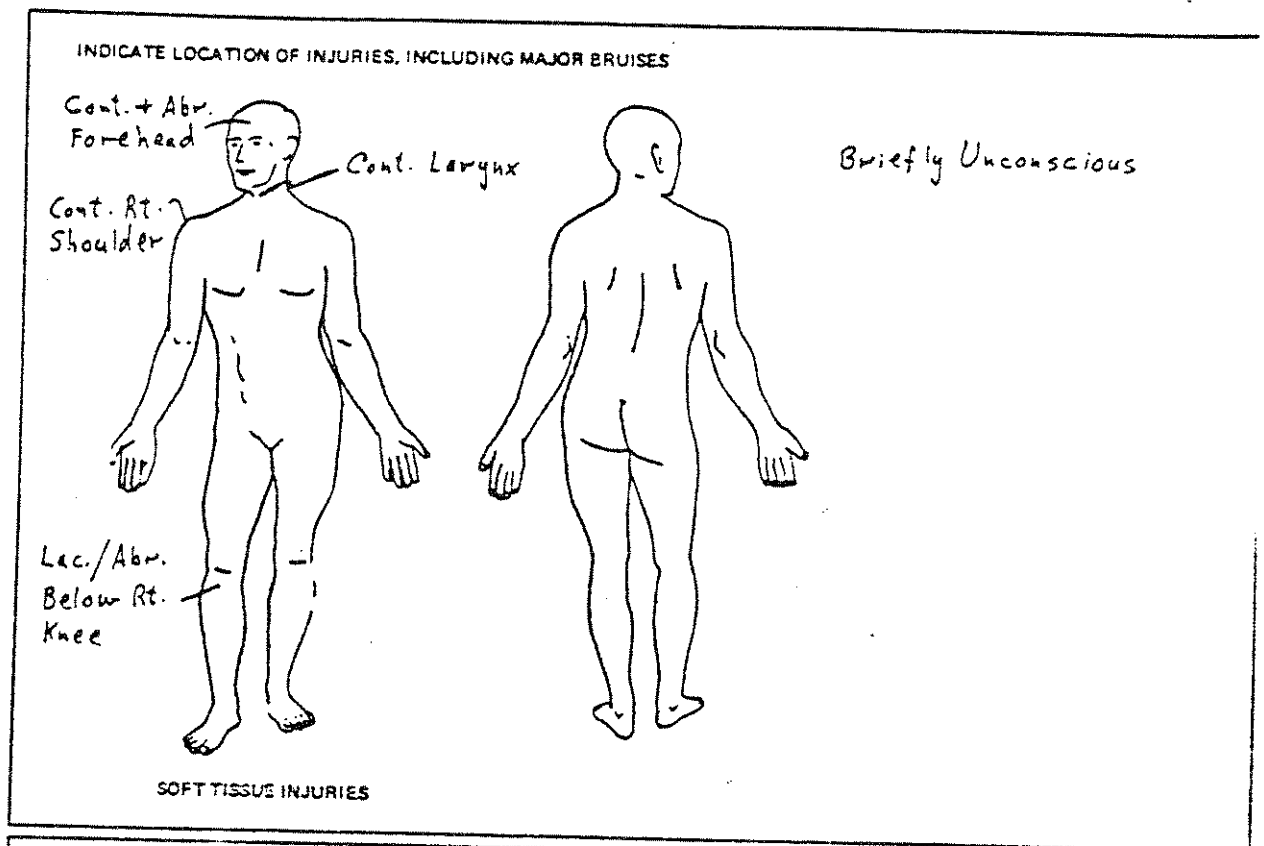
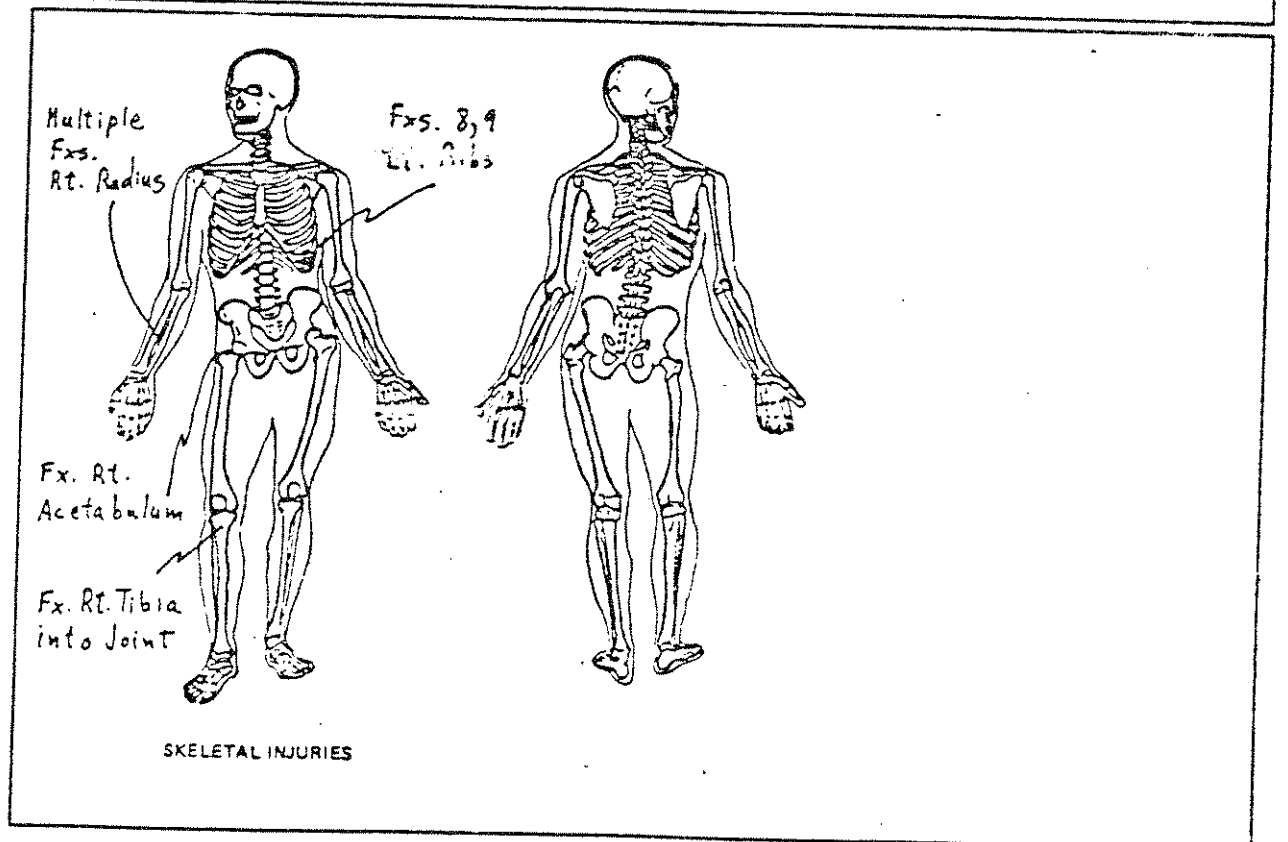
Figure 18. Occupant Injuries (Case No. 10).

This case involves a more severe frontal crash than in Case 9 (28.6 mph versus 22.9 mph) with an older, smaller male driver (50 years old) of a larger car. The contact of the head with the header was not as severe as the windshield contact, which produced a peak of 1600 lbs.--well below frontal bone fracture tolerance. The head acceleration associated with the windshield contact was higher than that of Case 9 (150 G peak) but with a lesser duration. Similar longer duration acceleration peaks around 80 G occurred late in both crashes. The subject was only briefly unconscious.

The contact of the subject's chest with the steering wheel was not as uniform or aligned as in Case 9 due to configurational differences in the vehicle interior and the subject positioning. A peak chest load of 1200 lbs. was produced. The fractures of the 8th and 9th ribs on the left side may have been due to the interaction of the bottom half of the steering wheel as shown in Figure 21. The age of the subject may also have had an influence on the production of skeletal damage at the lower load of 1200 lbs. Despite the lower load, the peak chest accelerations were slightly higher (55 G) than in Case 9.

The average femur contact force was 1550 lb. on each leg. The average tibial force was 900 lb. per leg and the total average femur load would be 2450 lb. per leg. The deformation of the instrument panel due to knee contact was greater on the left side and may have contributed to more of the load being carried by the right leg. The fracture of the right tibia occurred with a predicted load of at least 900 lbs. Both the age and the lesser lower leg development of their subject may have also influenced the initiation of this fracture at loads successfully sustained in Case 9. The subject also sustained a fracture of the right acetabulum, again at a load of at least 2450 lbs. but most likely greater than that. Both of these

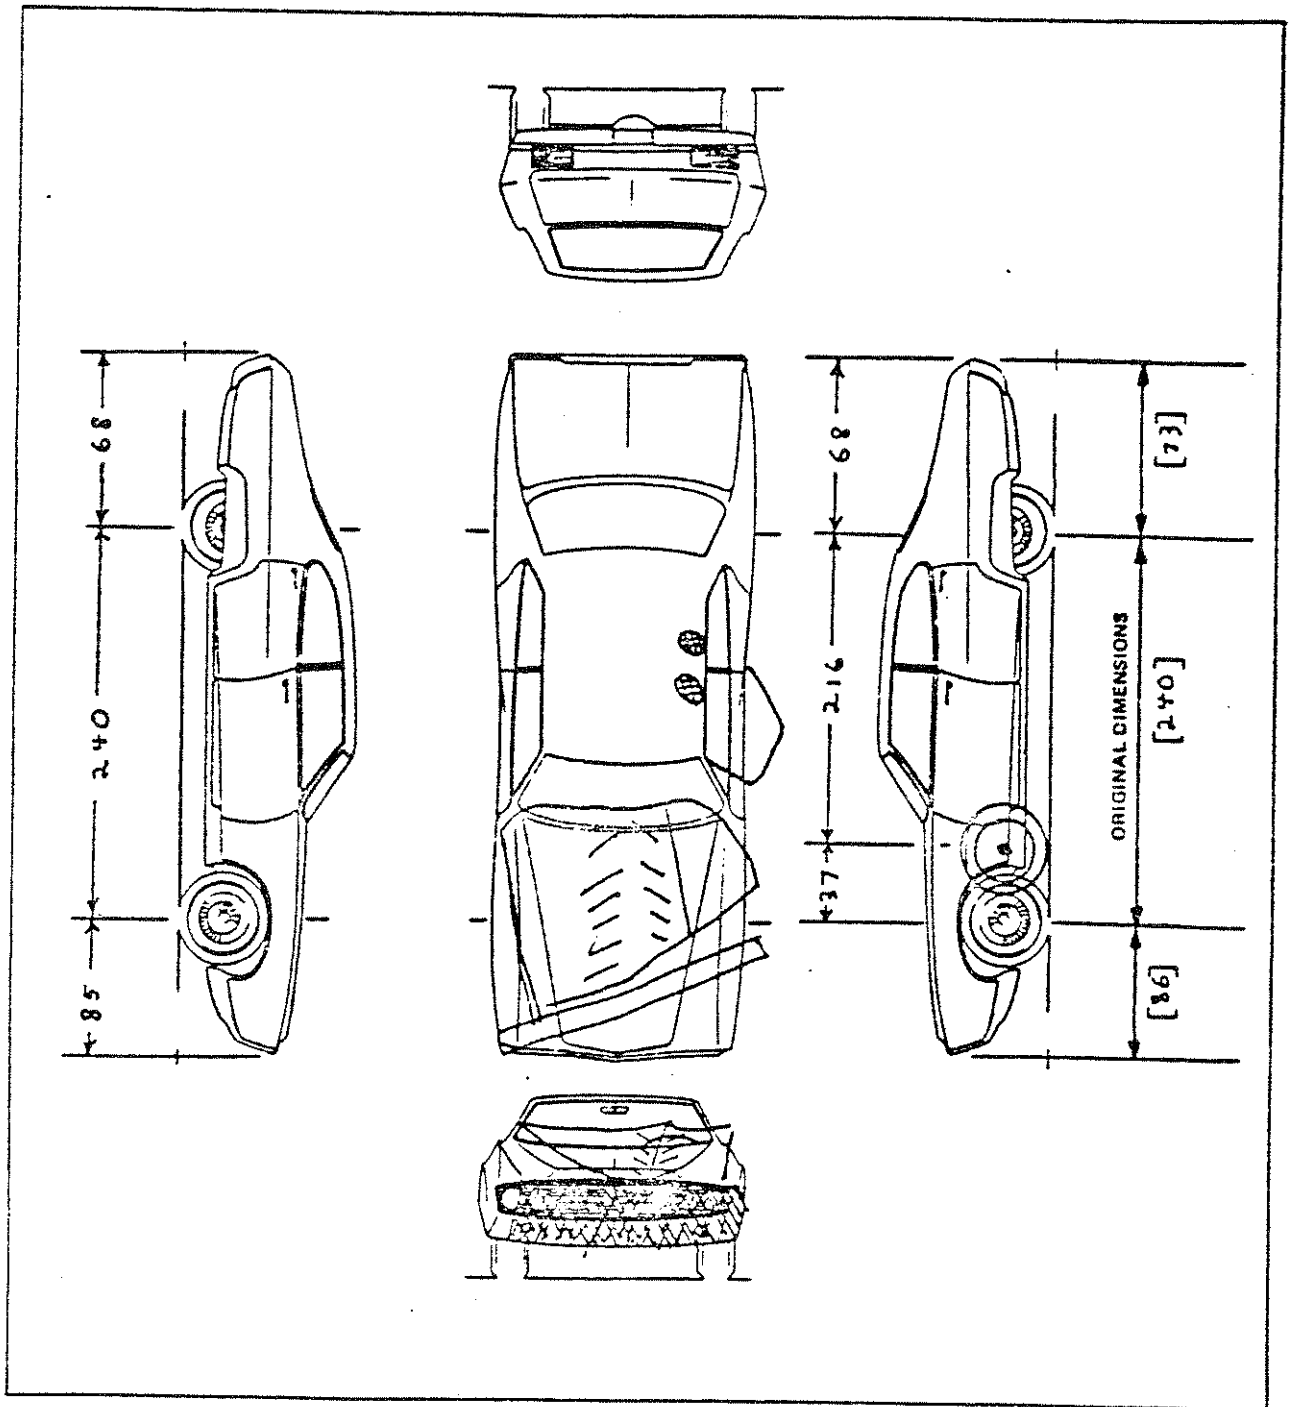
Figure 29. Vehicle Damage (Case No. 13).

In this case a 1980 Volkswagen Rabbit was driving on a two-lane road. A Chevrolet Blazer crossed the centerline on an icy turn. The impact energy transfer was nearly "head-on" for the Rabbit. Figure 28 is a schematic of the accident scene. Figure 29 shows the damage to the vehicle.

The fairly extensive damage to the vehicle interior was concentrated in the left front corner of the passenger compartment. The left end of the instrument panel was partially separated from the deformed left A-pillar. The steering wheel rim was slightly deformed from the driver apparently bracing his hands against it. There was some evidence of steering column movement to the left and slightly upward. The interior of the left door was deformed and the glass broken out due to impact but it is unknown if there was contact by the driver. There was intrusion of the instrument

panel which forced the knee bolster back toward the driver's knees. The floorpan was buckled and the driver's seat adjuster deformed. The instrument panel around the instrument cluster was damaged and the damaged rear-view mirror was dislodged from the severely crazed windshield, but it is unknown if there was any occupant contact.

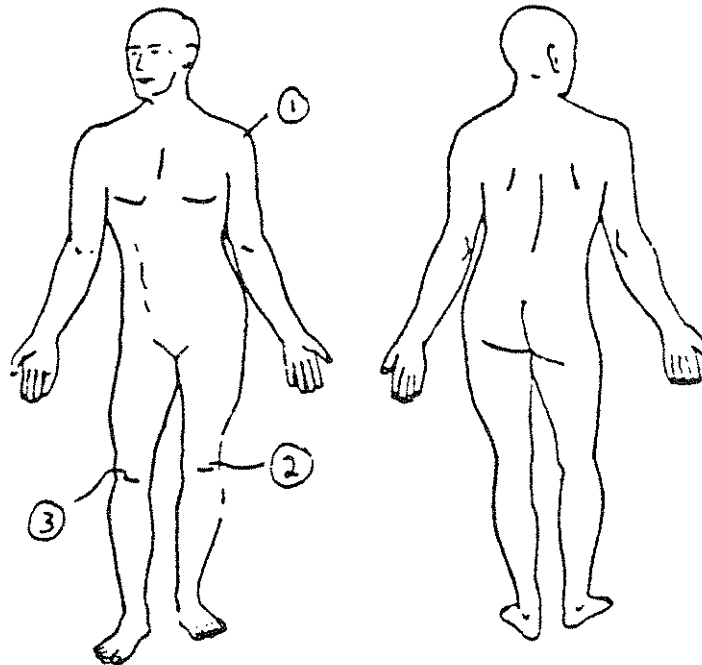
1. Cont. Left Shoulder
2. Partial tear. Lt. Posterior Cruciate Ligament
3. Tear, Rt. Anterior Cruciate Ligament

Unlike the previous two cases, this frontal crash involved a passively restrained driver (47 years old) at a much greater impact severity (36.7 mph). Due to the upper torso restraint belt, the head acceleration-time history was quite different from those of the previous cases. It was less abrupt in nature and had no contact spikes, although the peak reached 100 G. The duration of the waveform was much greater than the other two cases. No loss of consciousness was noted.

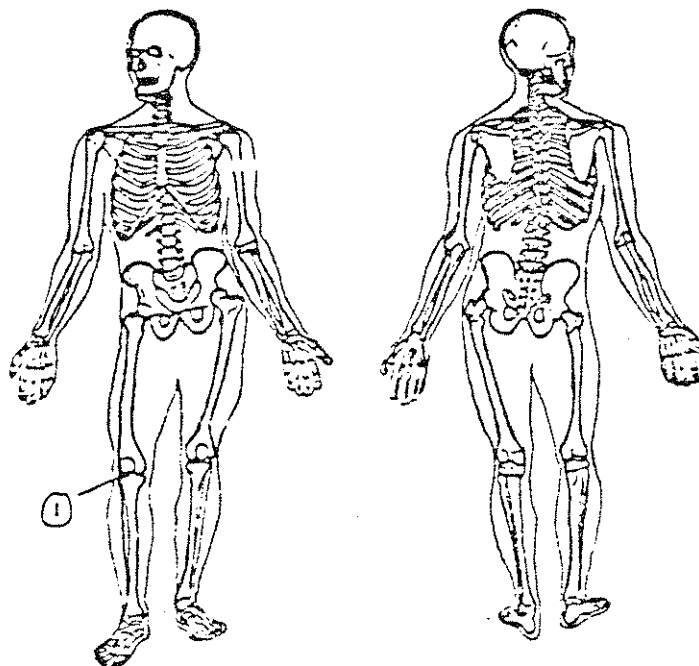
1. Split Fr. Rt. Tibial Plateau, Crushing Lateral Plateau, Avulsion Tibial Spine

The subject's lower leg geometry produced significant loading to the lower legs by contact with the knee bolster. The peak average force acting on each tibia was 2100 lbs., well above the level for ligamentous damage to cadaver knee joints. Both knee joints received ligament damage with the right tibial plateau sustaining a split fracture at these high load levels.

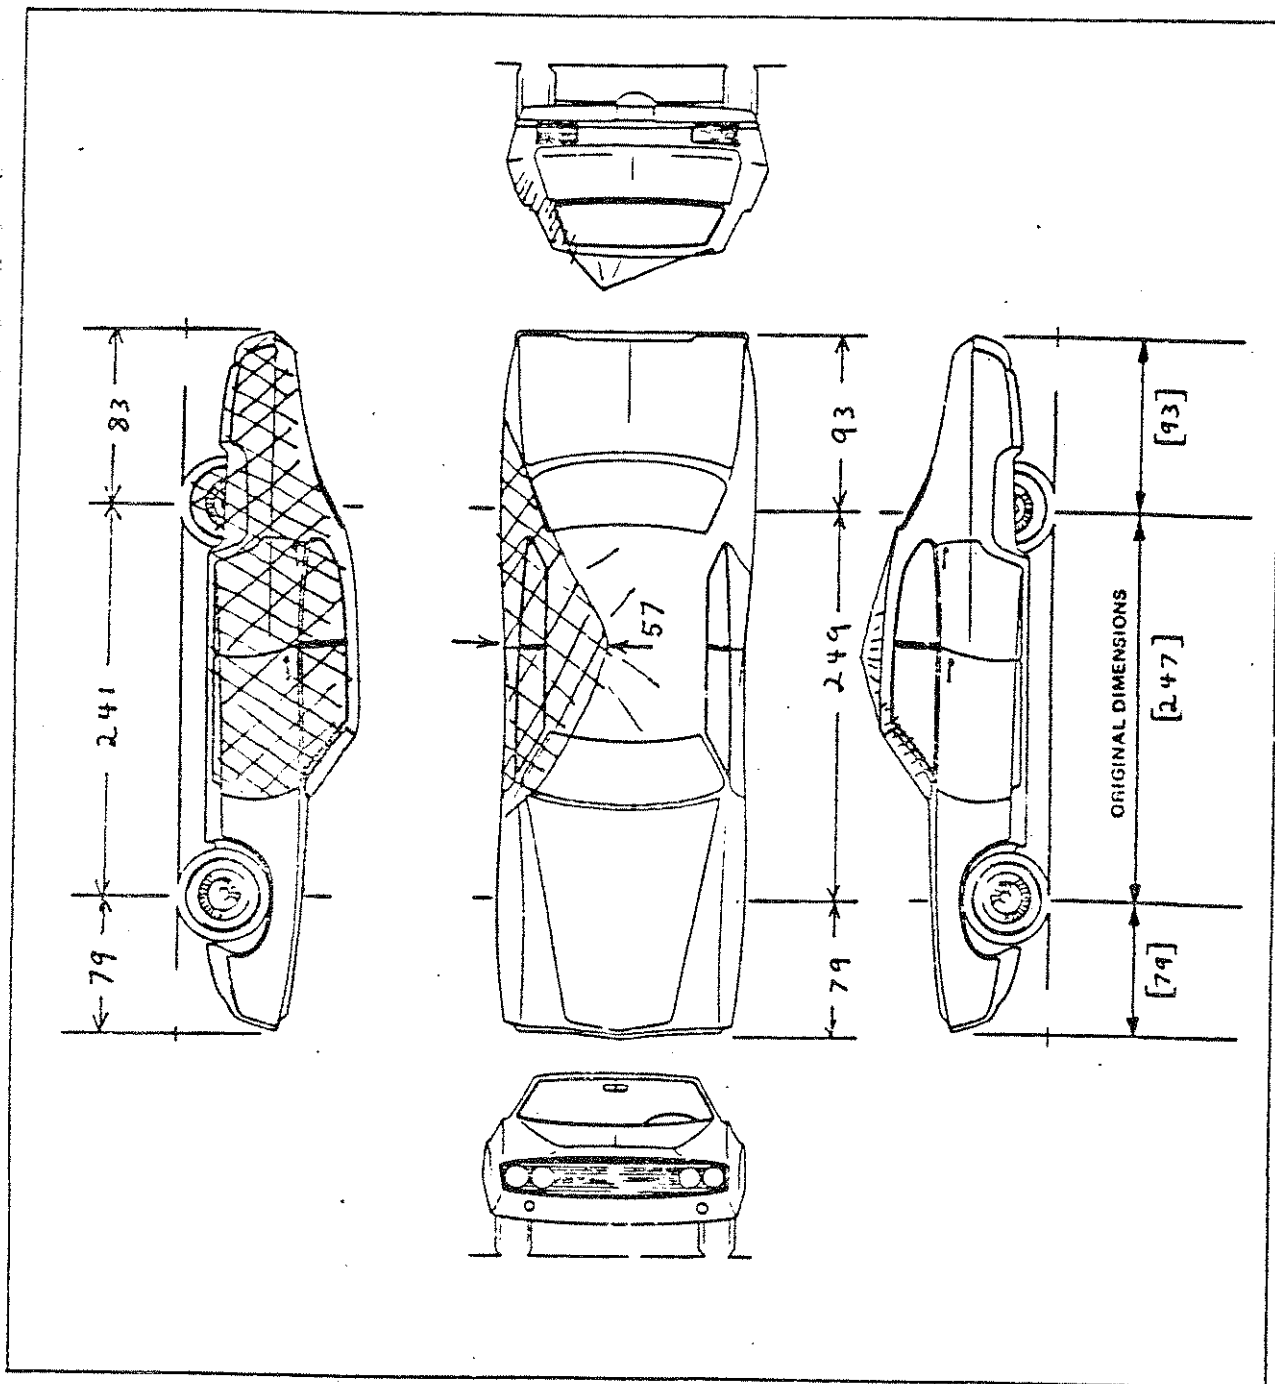
Figure 41. Vehicle Damage. (Case No. 14).

In this case a 1980 Chevrolet Chevette was struck in the side by a C/20 Chevy Van. Intrusion was extensive on the passenger's side. The female driver of the Chevette was wearing a lap-shoulder belt and sustained minimal injuries. A schematic of the accident scene is shown in Figure 40. Damage to the Chevette is shown in Figure 41. Although there was a spin by the subject vehicle, it appeared that the primary force vector was

Damage was extensive to the right side of the passenger compartment. The floor-mounted T-bar shift lever was bent to the right by the driver causing its plastic housing to crack. Deformation of the right upper A-pillar crazed the right half of the windshield, deformed the header, bowed the right sunvisor and deformed the roof in the front right corner. The front right door intruded about 41 cm (16.14 in) damaging its latch housing and the front right seat cushion and seat adjuster. Its window sill was also contacted by the driver. The right B-pillar intruded about 46 cm (18.11 in) damaging the front right seat back and causing it to bend to the left behind the driver's seat back. Intrusion of the right roof side rail deformed the roof.

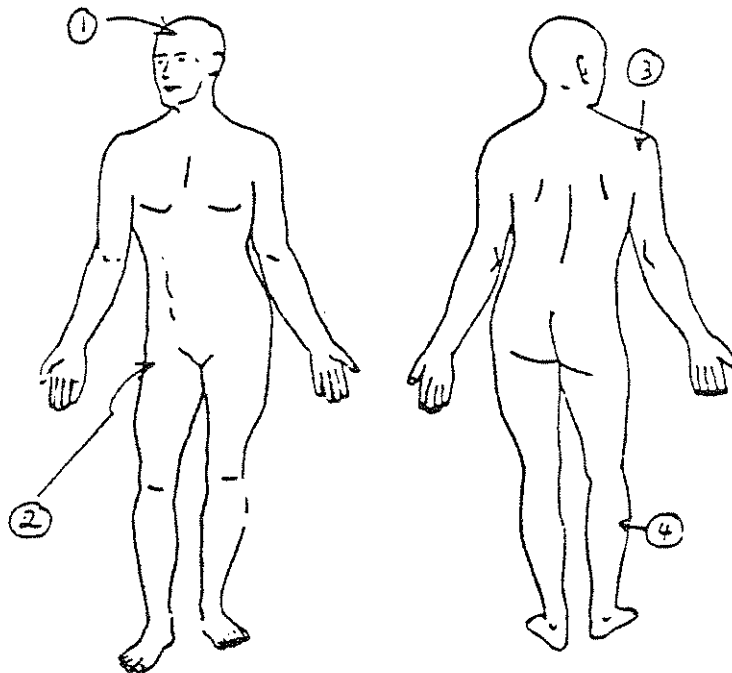
Figure 42. Occupant Injuries (Case No. 14).

1. Lac. Rt. Frontal Scalp
2. Cont. Rt. Proximal Anterior and Medial Thigh
3. Lac. Posterior Rt. Shoulder
4. Cont. Rt. Calf

This was a severe far-side impact involving a female driver restrained by a three-point belt system. The intrusion of the right side of the vehicle provided a significant head contact point which produced an abrupt 1350 lb. peak force to the head. The contact resulted in a laceration to the right frontal scalp of the subject. The load peak was well below skull fracture tolerance for a flat surface impact to the frontal bone. The lateral head accelerations were low except for the abrupt contact spike with a peak of 140 G. The vertical head accelerations were equally as high but with much greater duration during this contact. The subject was not concussed.
