Application and Use of Linear Interpolation Models: A Case Study

Eric Hunter, P.E.
Investigative Training Service, LLC.

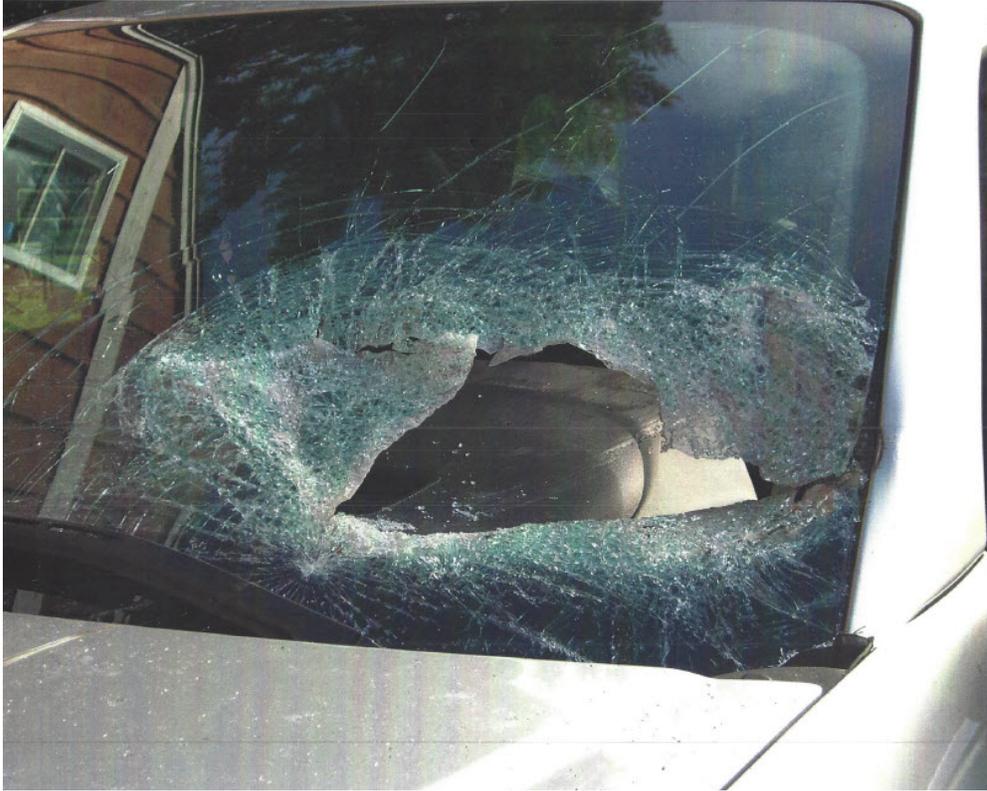
Figure 1: Impact and penetration location of pole through windshield at the driver's side A-pillar.

The vehicle that was being driven by the guest was an all wheel drive 2007 GMC Acadia. The damage to the vehicle was to the driver's side of the windshield, driver's headrest and the rearmost passenger's side window. The damage to the windshield consisted of a hole at the base of the driver's side A-pillar. The driver's side headrest was impacted by the end of the steel gate and was knocked off of the seat. The rearmost passenger's side window was shattered with evidence of contact to the rear of the passenger's c-pillar.

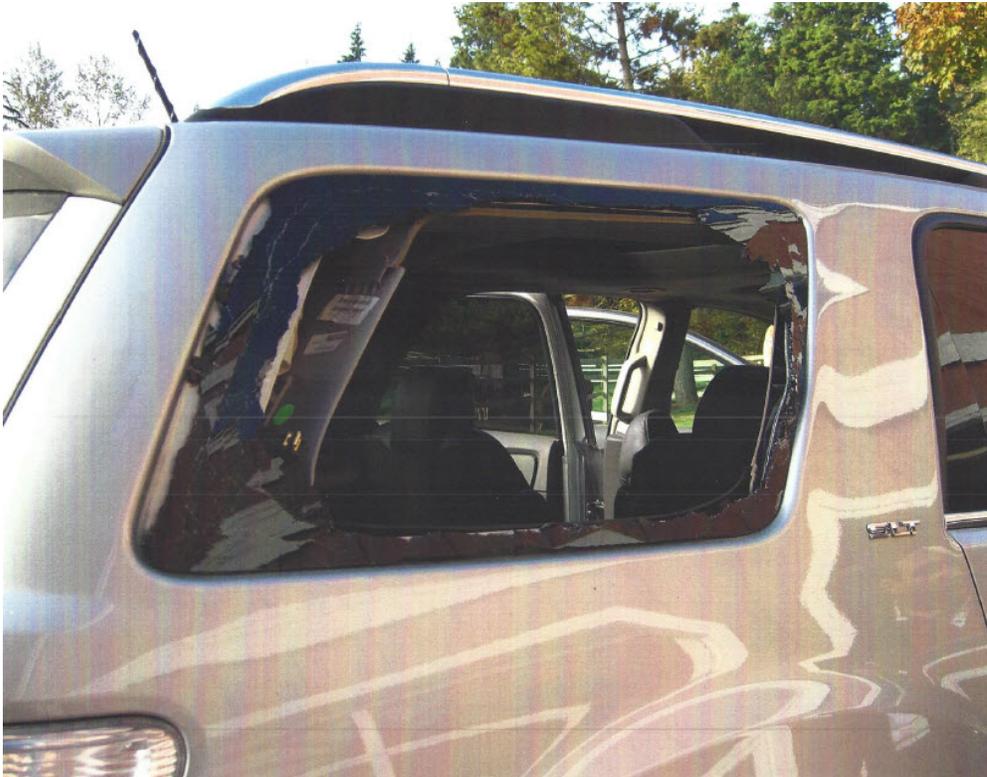
Figure 2: Pole exit location through small rearmost passenger's side window.

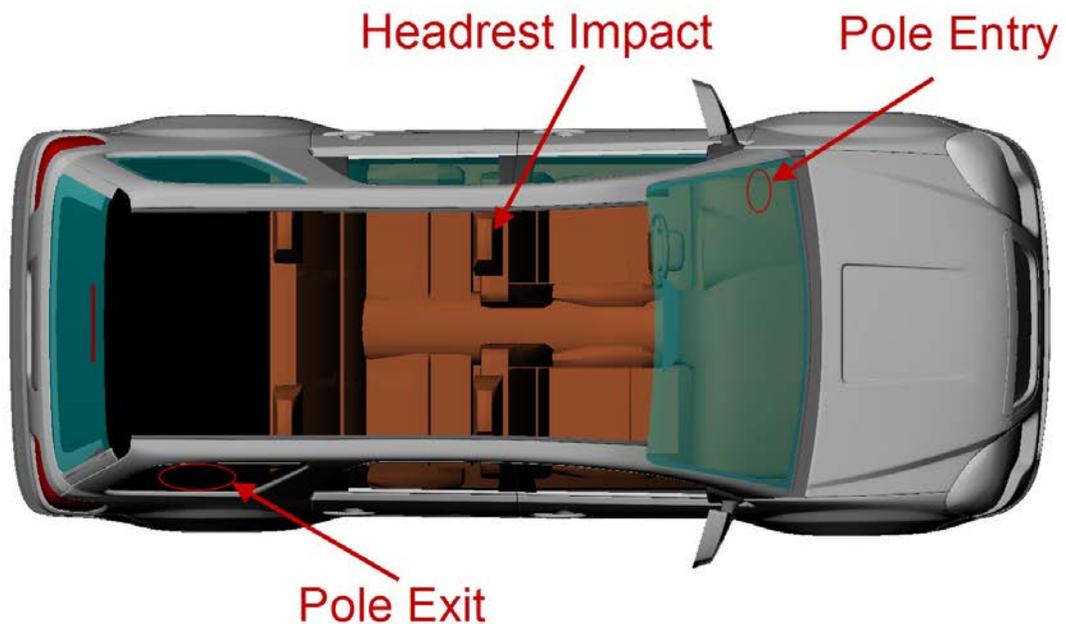
Figure 3: Damage to the vehicle from the pole.

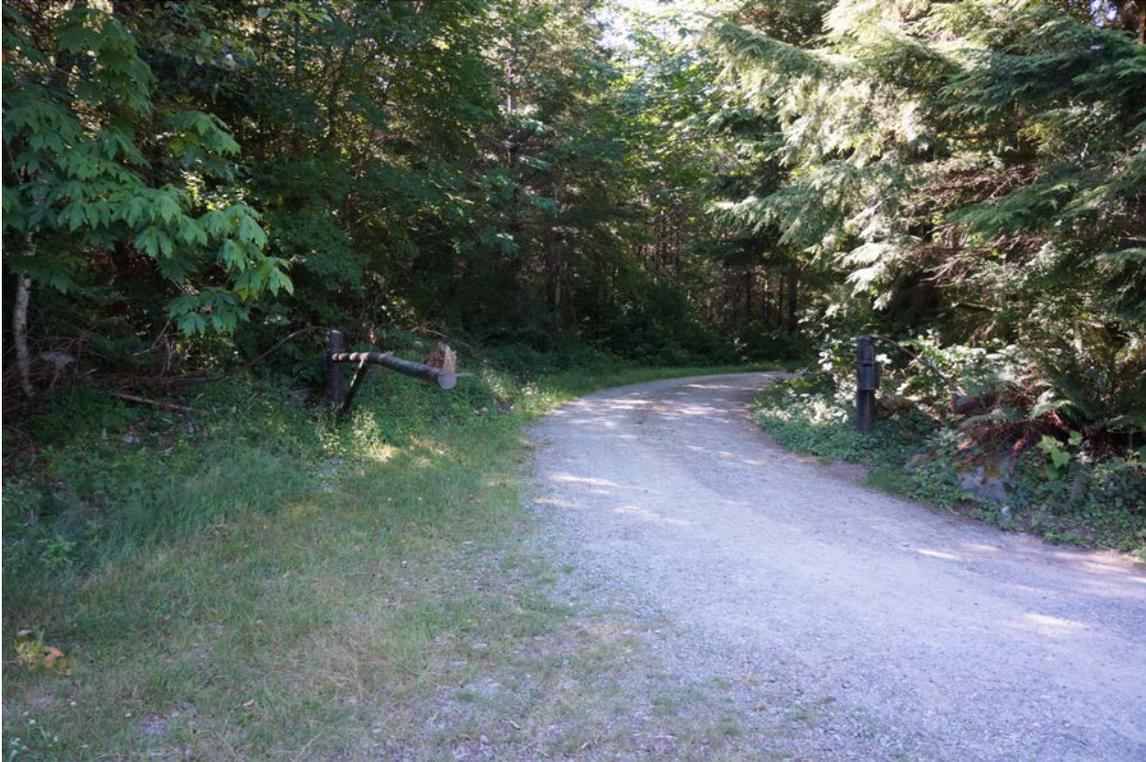
The steel gate was a 4.5 inch diameter capped cylinder that extended horizontally approximately 24 feet to the southern metal post. The author was informed that prior to the accident the gate was straight with no noticeable damage. At the time of the inspection the end of the gate had been bent 12 inches from the collision with the guest's vehicle. There was a clear "bend point" approximately 12 feet from the end of the gate.

Figure 4: Photograph of the roadway showing the pole involved in the accident.

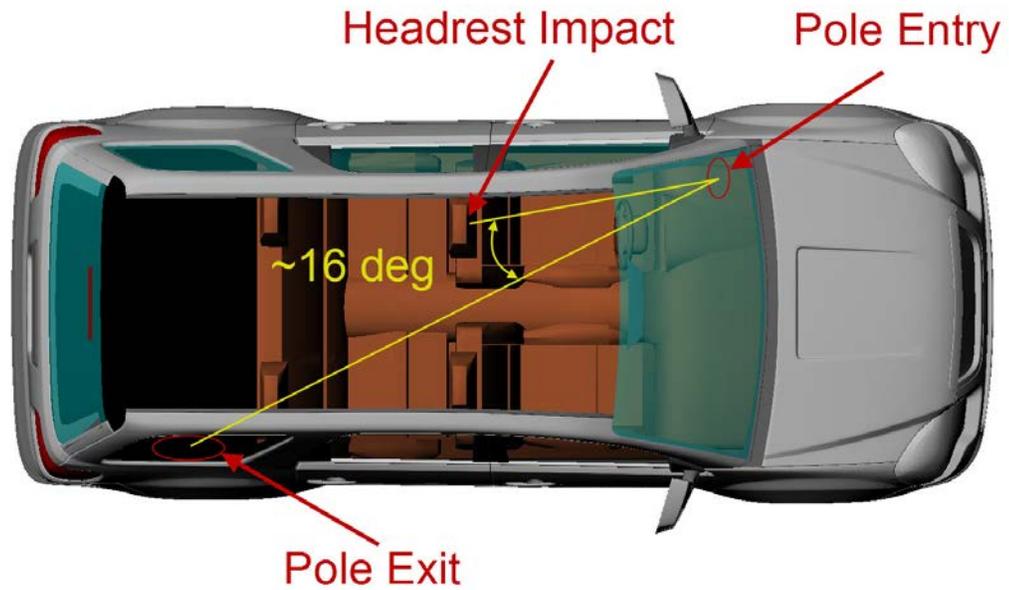
Figure 6: Path of travel of pole through the vehicle.

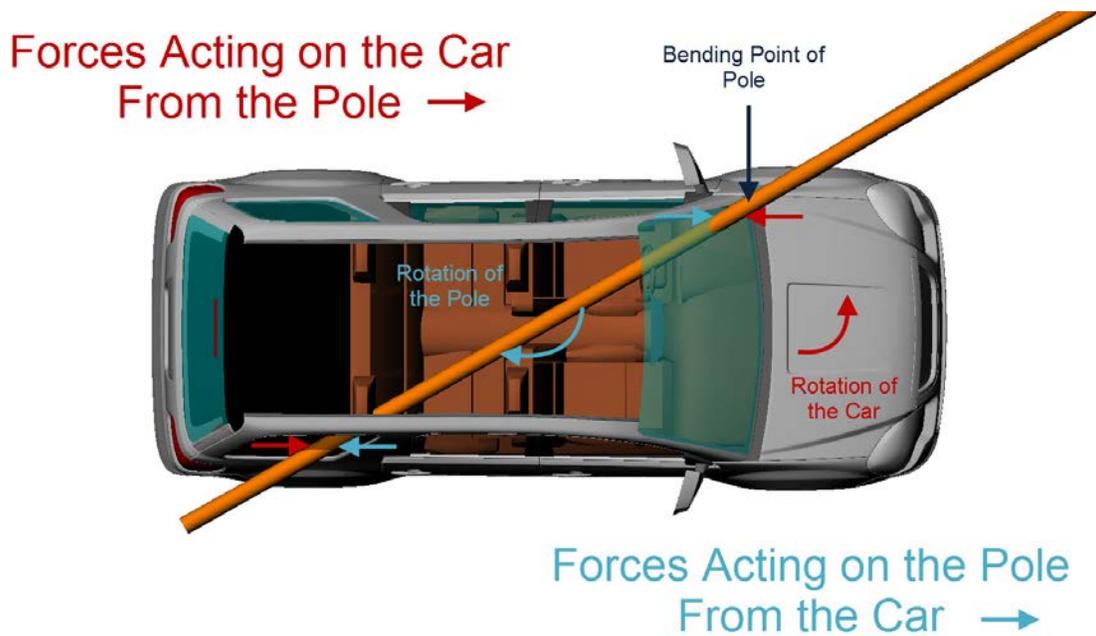
Figure 7: Diagram of forces from pole-vehicle interaction.

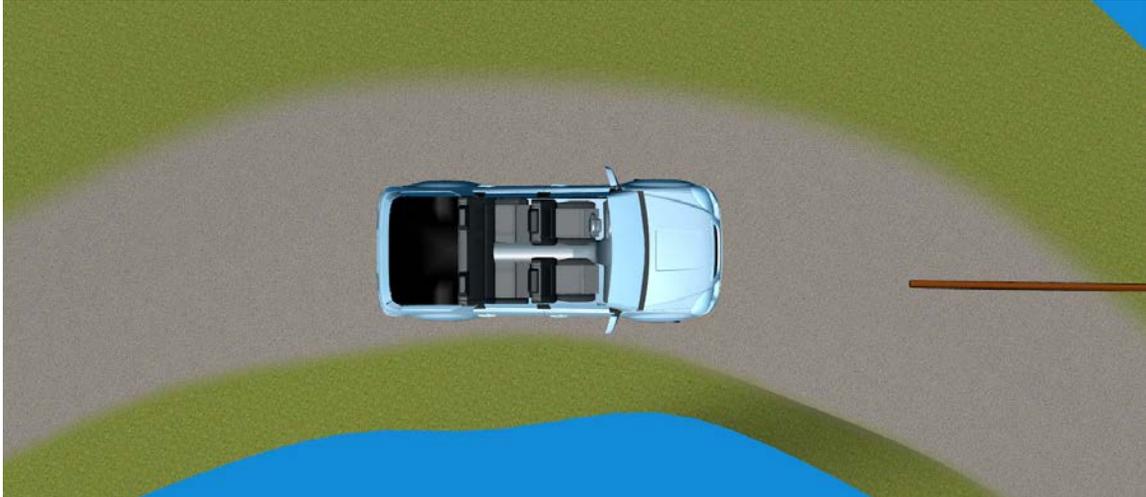
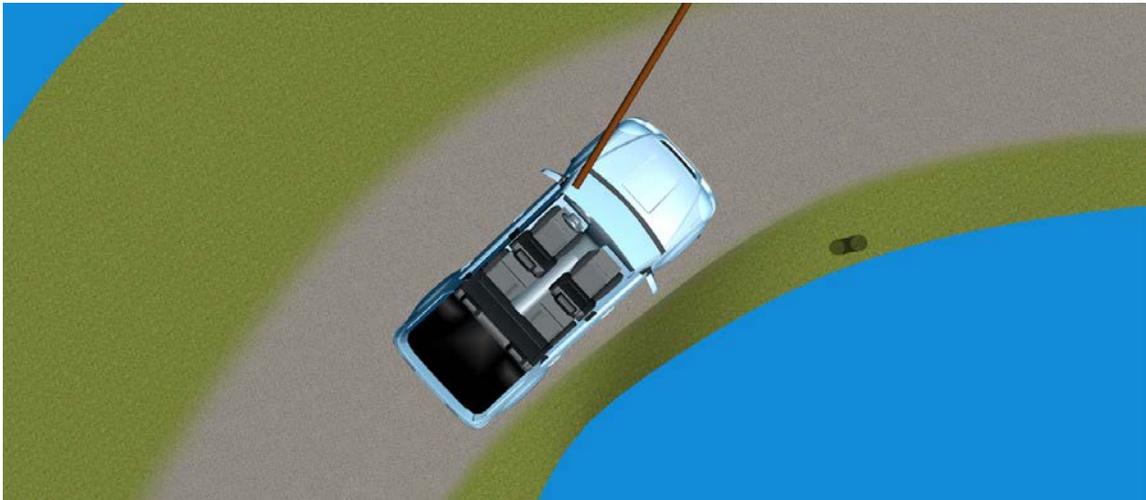
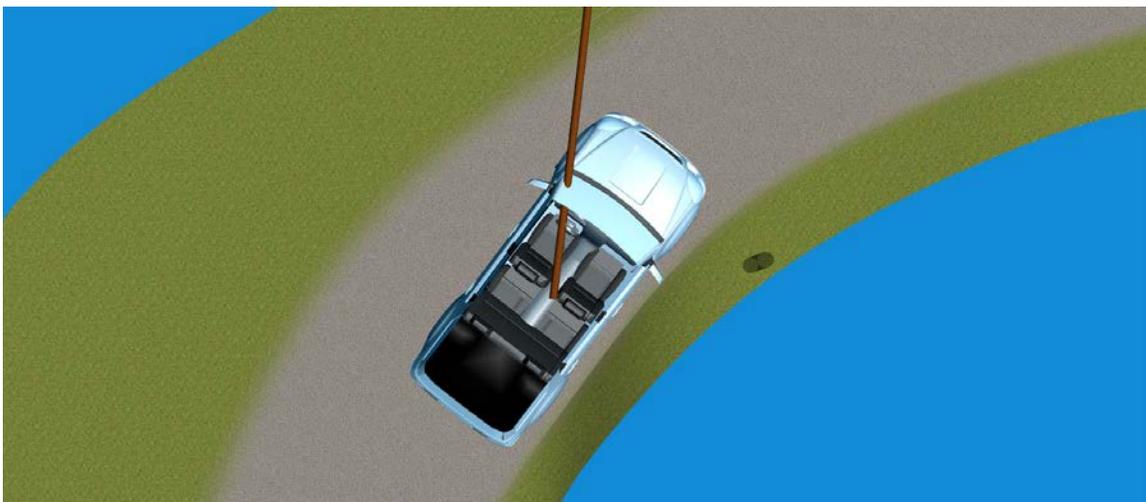
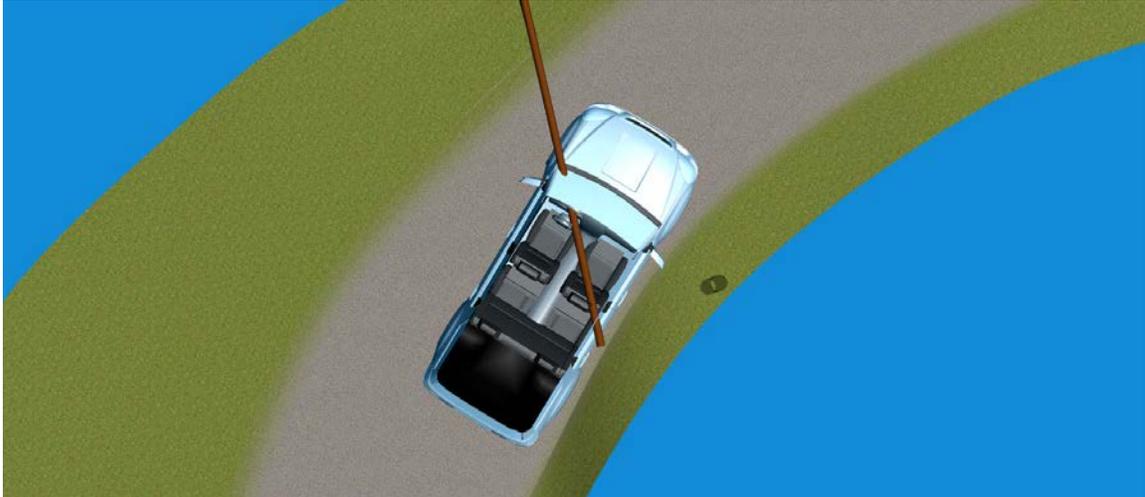
The first scenario was as described by the guest with the end of the gate in the middle of the driveway. The EDGEN run was continuously modified through the EDGEN event so that the end of the gate penetrated the windshield at the base of the driver's side A-pillar and traveled through the interior of the vehicle to match the contact points within the vehicle as best as possible. With the understanding that the gate would make contact with the forward/interior portion of the driver's side A-pillar without deforming it, the gate was iteratively rotated about the southern pivot post so that the side of the gate never "penetrated" the A-pillar. Due to the specific damage and path of the gate through the GMC Acadia, the A-pillar was a constraint for the nature of the gate rotation. With the vehicle driving at a constant speed near the center of the roadway and following the contour of the single lane, the end of the gate could penetrate the windshield at the proper location but would have been "pushed" forward by the driver's side A-pillar such that the gate rotated to exit the vehicle through the right rear passenger's window. Under this scenario the gate would not have contacted the driver's headrest and would also exit the wrong passenger's side window (see figure 8 through 11).

Figure 8: Vehicle traveling in the center of the road with the pole located near the center of the road.

Figure 9: Pole penetrating the windshield.

Figure 10: Pole rotating due to contact with driver's side A-pillar.

Figure 11: Pole continuing to rotate due to contact with the driver's side A-pillar and exiting the incorrect rear passenger's side window.

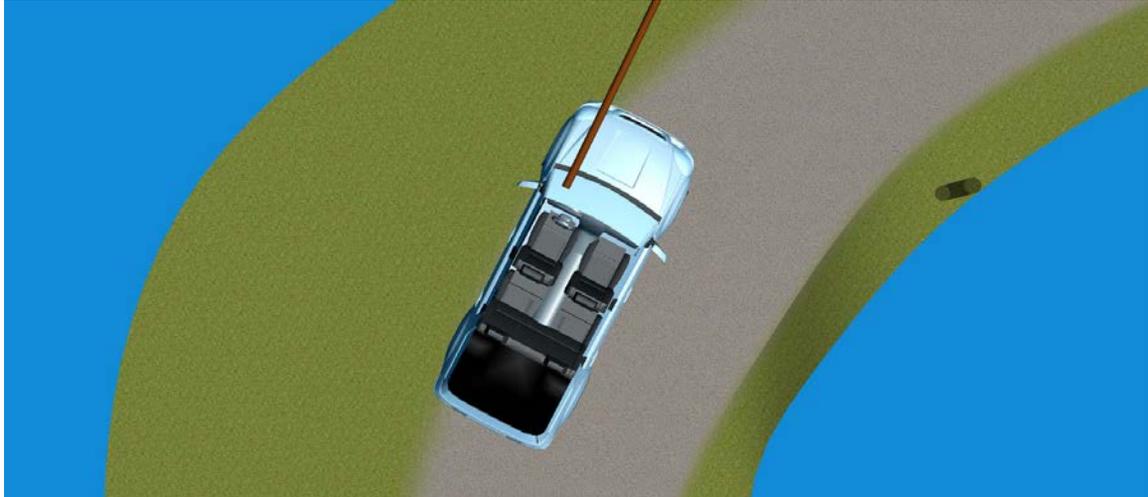
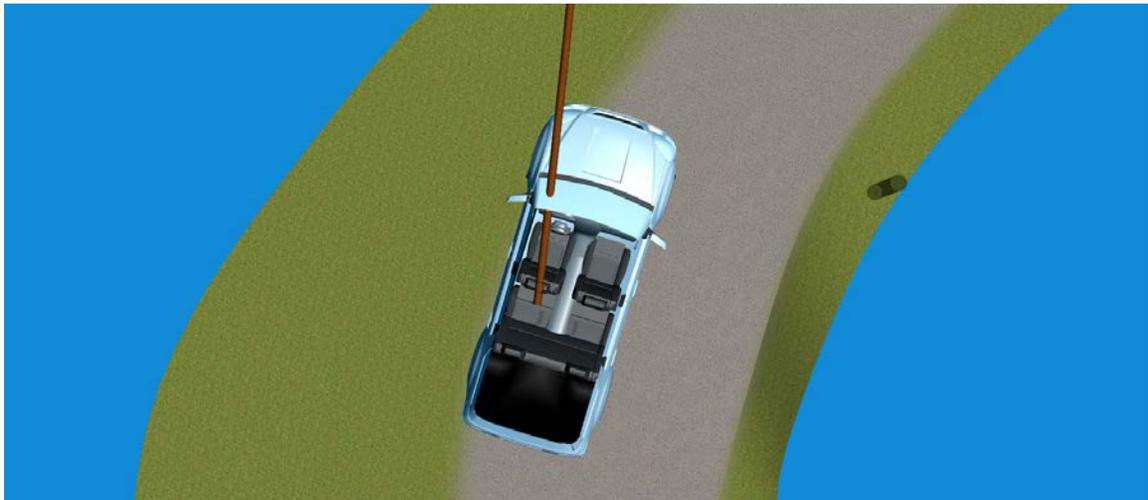
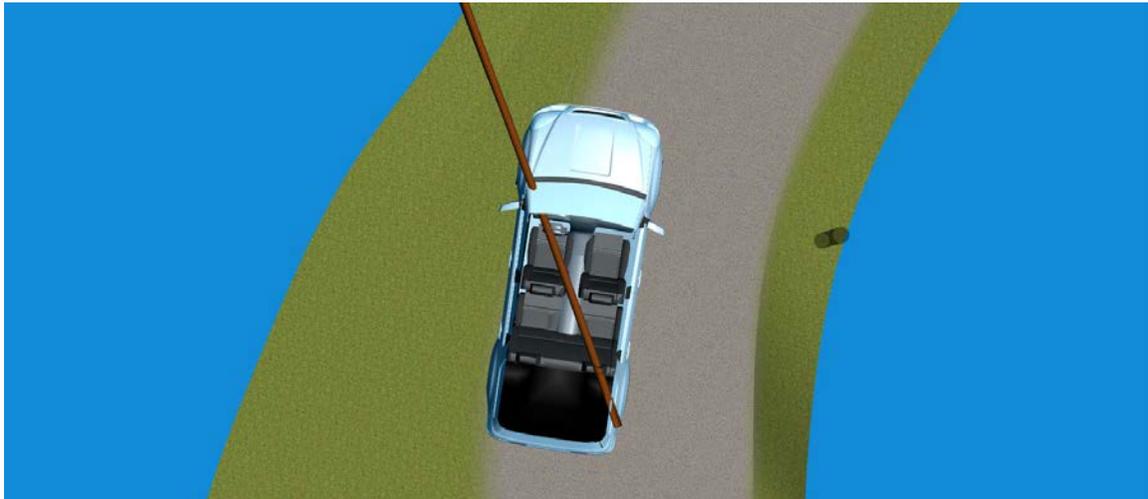
The second scenario was as described by the property owner with the end of the steel gate off of the traveled portion of the roadway and on the grass shoulder. The EDGEN run was continuously modified through the EDGEN event so that the end of the gate penetrated the windshield at the base of the driver's side A-pillar and traveled through the interior of the vehicle to match the contact points within the vehicle as best as possible. The gate was iteratively rotated about the southern pivot post so that the side of the gate never "penetrated" the A-pillar. With the vehicle driving at a constant speed at the edge of the roadway and following the contour of the single lane, the end of the gate could penetrate the windshield at the

proper location, impact the driver's headrest and rotate to exit the rearmost passenger's side window. After penetrating the rearmost passenger's side window the forward motion of the Acadia created a lever situation for the gate with the southern post acting as the fulcrum. The gate remained secured at its base with the southern post as force was applied in a forward direction by the driver's side A-pillar and a rearward force applied by the passenger's side c-pillar. The result caused the steel gate to bend at a location approximately 12 feet from the end. The second scenario matched the damage to the interior of the GMC Acadia and was a good match for the location of the bend in the steel gate (see figure 12 through 14).

Figure 12: Vehicle traveling at the edge of the roadway with the end of the pole located off of the traveled portion of the road showing the pole penetrating the windshield.

Figure 13: Pole traveling through the vehicle to impact the driver's side headrest.

Figure 14: Pole rotates due to contact with the driver's side A-pillar to exit the rearmost passenger's side window.
