Observational Validation of the SIMON Steer Degree-of-Freedom Model: A Case Study

Maximilian Lee and Cline Young
Cline Young, Consulting Engineer

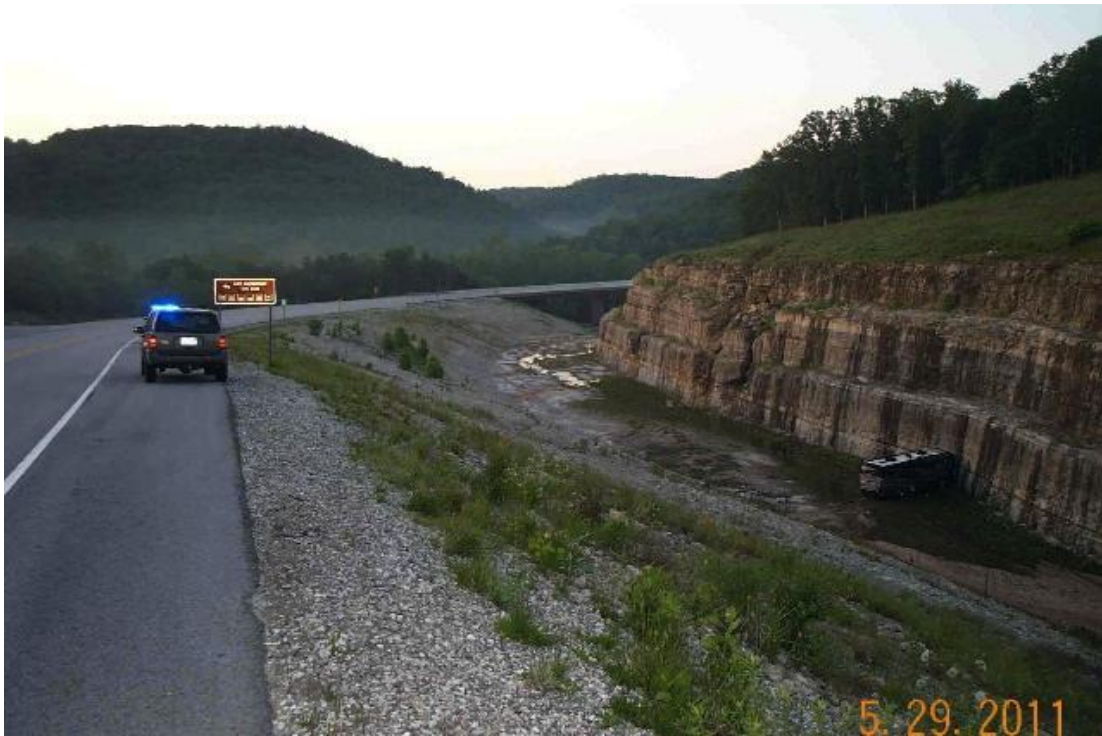
Figure 1: Jeep in spot where motorhome was unhitched and motorhome at point of rest

An accident occurred near Eureka Springs, AR, in which a motorhome rolled out of control down an embankment, across a flat basin, and into a vertical cliff face, resulting in a total loss of the vehicle. The owner had been driving the motorhome eastbound through difficult and hilly terrain on a US highway. He claims to have experienced some problems with the brakes and was barely able to bring the vehicle to a stop on the eastbound shoulder. He decided to take his Jeep, which was attached to the rear of the motorhome, into Eureka Springs to look for a mechanic to repair his brakes. Shortly after setting his parking brake and detaching his Jeep from the motorhome the brakes were claimed to have failed completely and the motorhome rolled freely down the embankment. Numerous photographs were taken documenting the position of the Jeep at the detachment location and the position of the motorhome at point of rest.

The scene photographs clearly show the position from which the motorhome started and its position at point of rest. There was no observable path of travel in between the two points but a high level of accuracy was not required in this case in order to answer the question of starting position.

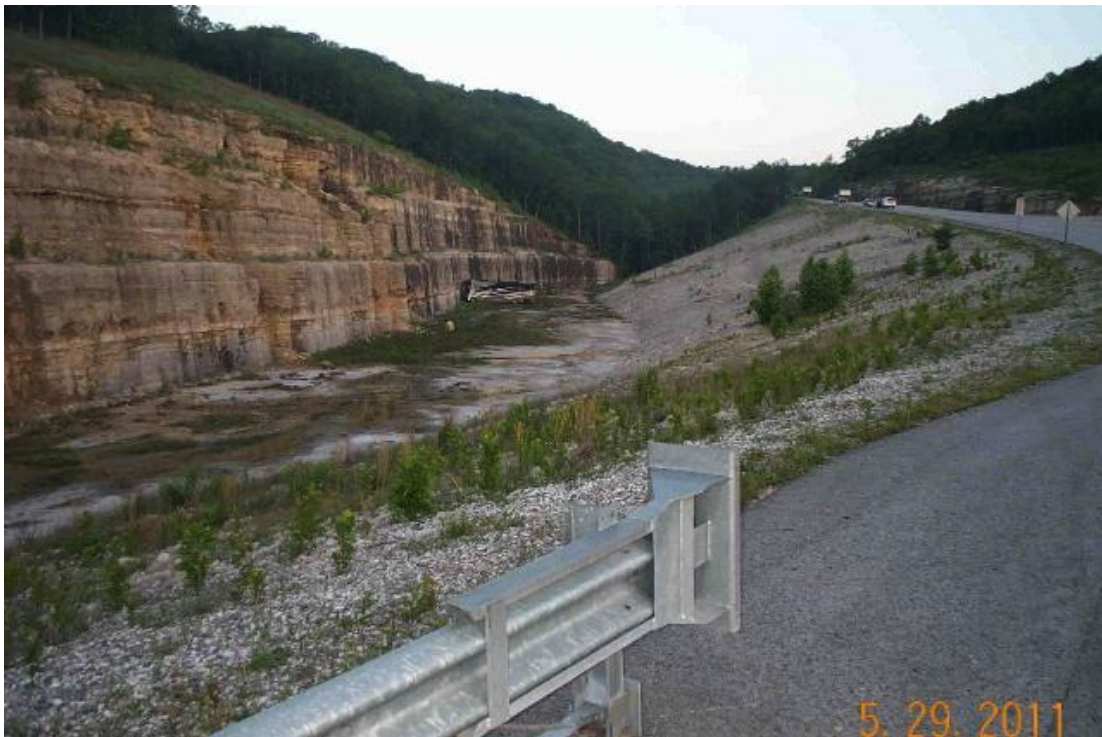
Figure 2: View from the east of the vehicles at POR

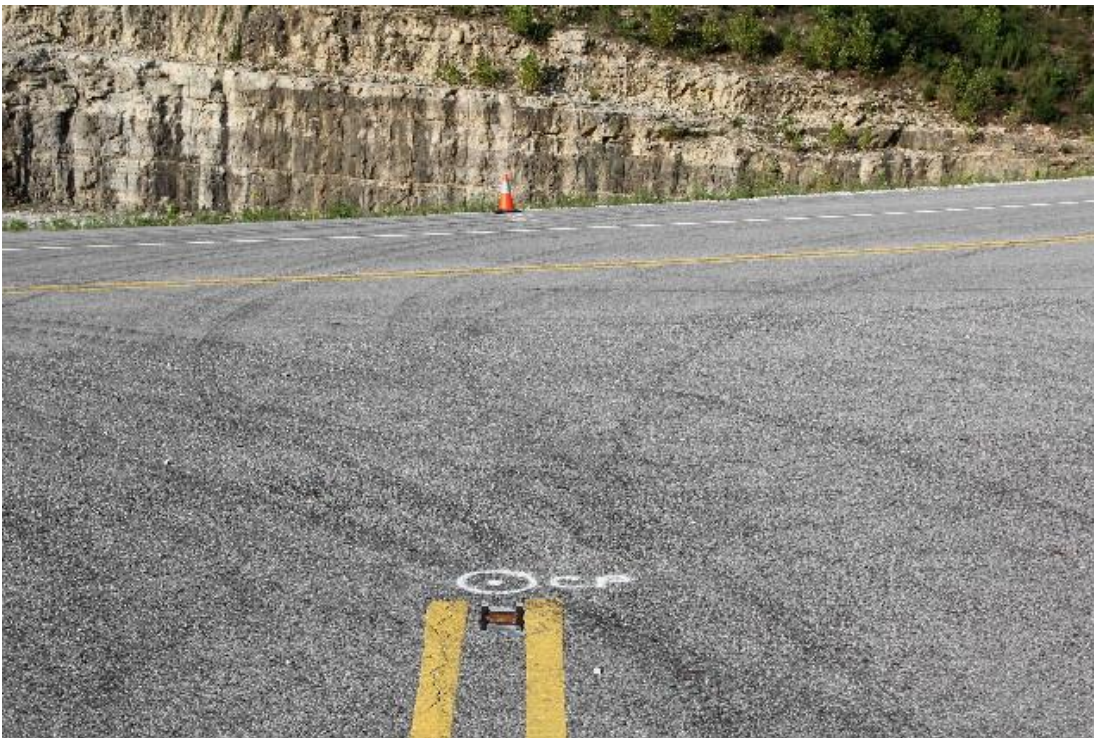
Figure 3: View of the southbound centerline at intersection with eastbound road

The office of Cline Young, Consulting Engineer was contacted and asked to determine how a driverless vehicle would perform under the various slopes and grades. More specifically, the question that was posed dealt directly with determining if the motor home were indeed initially parked parallel to the drainage basin, on the eastbound shoulder of the US highway, or had it begun its travel on the intersecting southbound roadway.

Contrary to the beliefs of the police, wrecker driver, and claims agent, the motorhome clearly did not start from the intersecting roadway headed straight south in a driverless fashion. The only way it could have arrived at the correct impact spot from there was if it had been steered, but there was clear evidence that no one was aboard the vehicle as it traversed the various slopes.

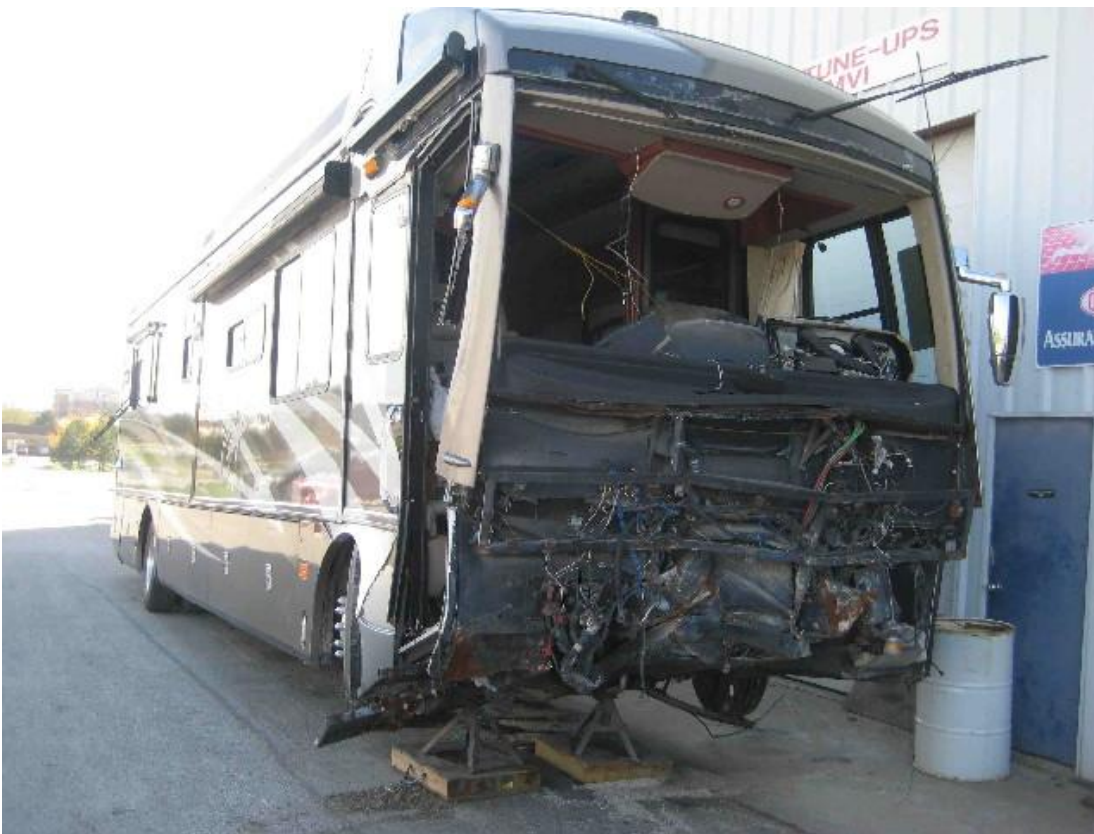
Figure 4: Front damage on motorhome due to impact with cliff face

Third, the motor home was inspected and wheelbase measured with overhangs front and rear. The crush too was measured. The crush on the driver's side measured to be 4 inches. On the passenger's side it was 20 inches. There was no displacement of the front axle on the driver's side but about 5 inches of displacement on the passenger's side. The tires were type Michelin X Pilote XZA1 295/80R22.5. Extensive measuring and testing of the brakes (the primary purpose for the inspection) took place but since that has no contribution to make to the purpose of this paper the data and discussion will be omitted. The rear overhang was also damaged due to the sudden and steep change in the topography at the bottom of the slope.

The 3 degree Off Parallel simulation shows the motorhome striking the cliff face at about 38 mph. Since a crush data database regarding Recreational Vehicles does not currently exist, it is difficult to confirm this speed with the damage seen in the photographs. However, this final velocity is not unreasonable to assume given the downgrade of the slope and lack of any braking. It could be useful for EDC to be collecting anecdotal data from cases such as this involving crush on heavy vehicles.

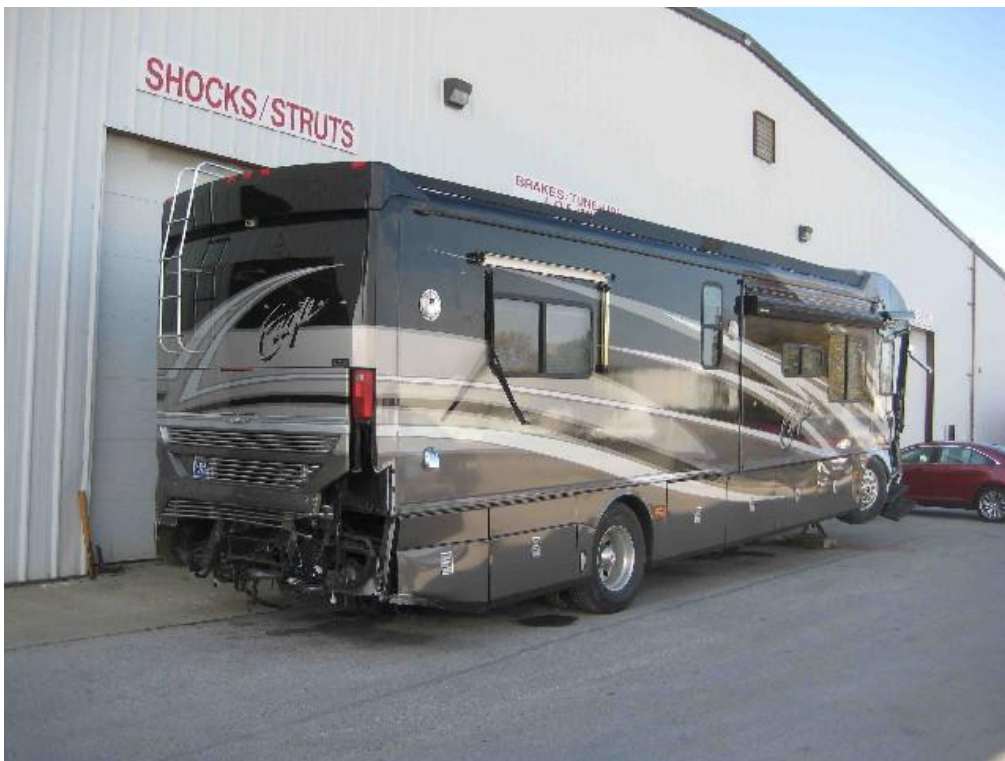
Figure 5: Rear overhang damage due to discontinuity between slope and basin bottom
