UMTRI-83-3

Biomechanical Accident  
Investigation Methodology

Final Report  
February 1983

Prepared for  
Motor Vehicle Manufacturers Association  
320 New Center Building  
Detroit, Michigan 48202

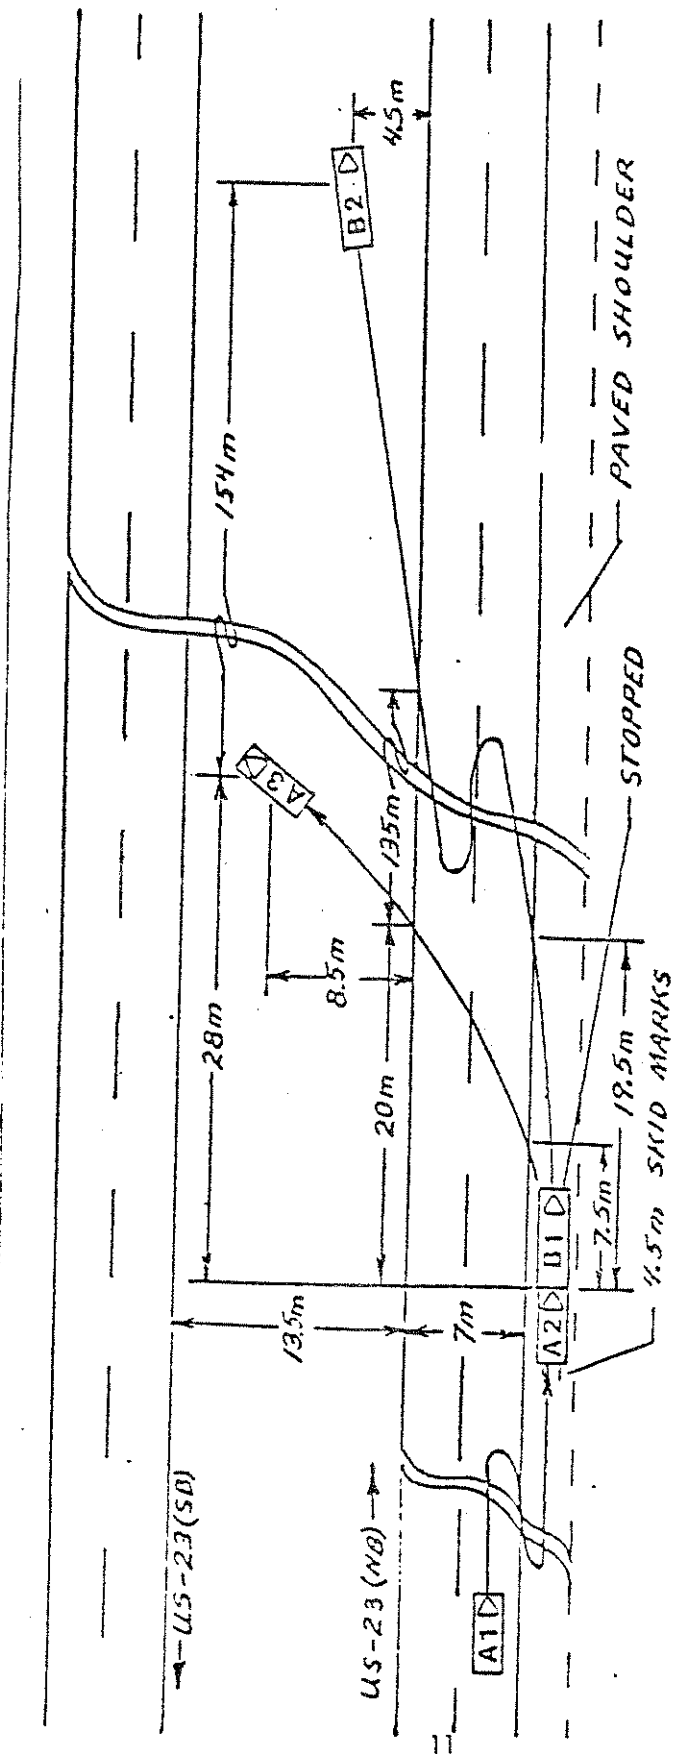
Figure 1. Schematic of Accident Scene (Case No. 9).

In this case a 1981 Mercury Lynx driven by a 35 year old male was driving on a freeway when it struck the rear of a 1972 Chevrolet Nova which was stopped on the paved right shoulder of the roadway. Figure 1 is a schematic of the accident scene showing the square rear-end impact as well as the well-defined resting points of the vehicles. Figure 2 shows the damage to the front end of the Lynx.

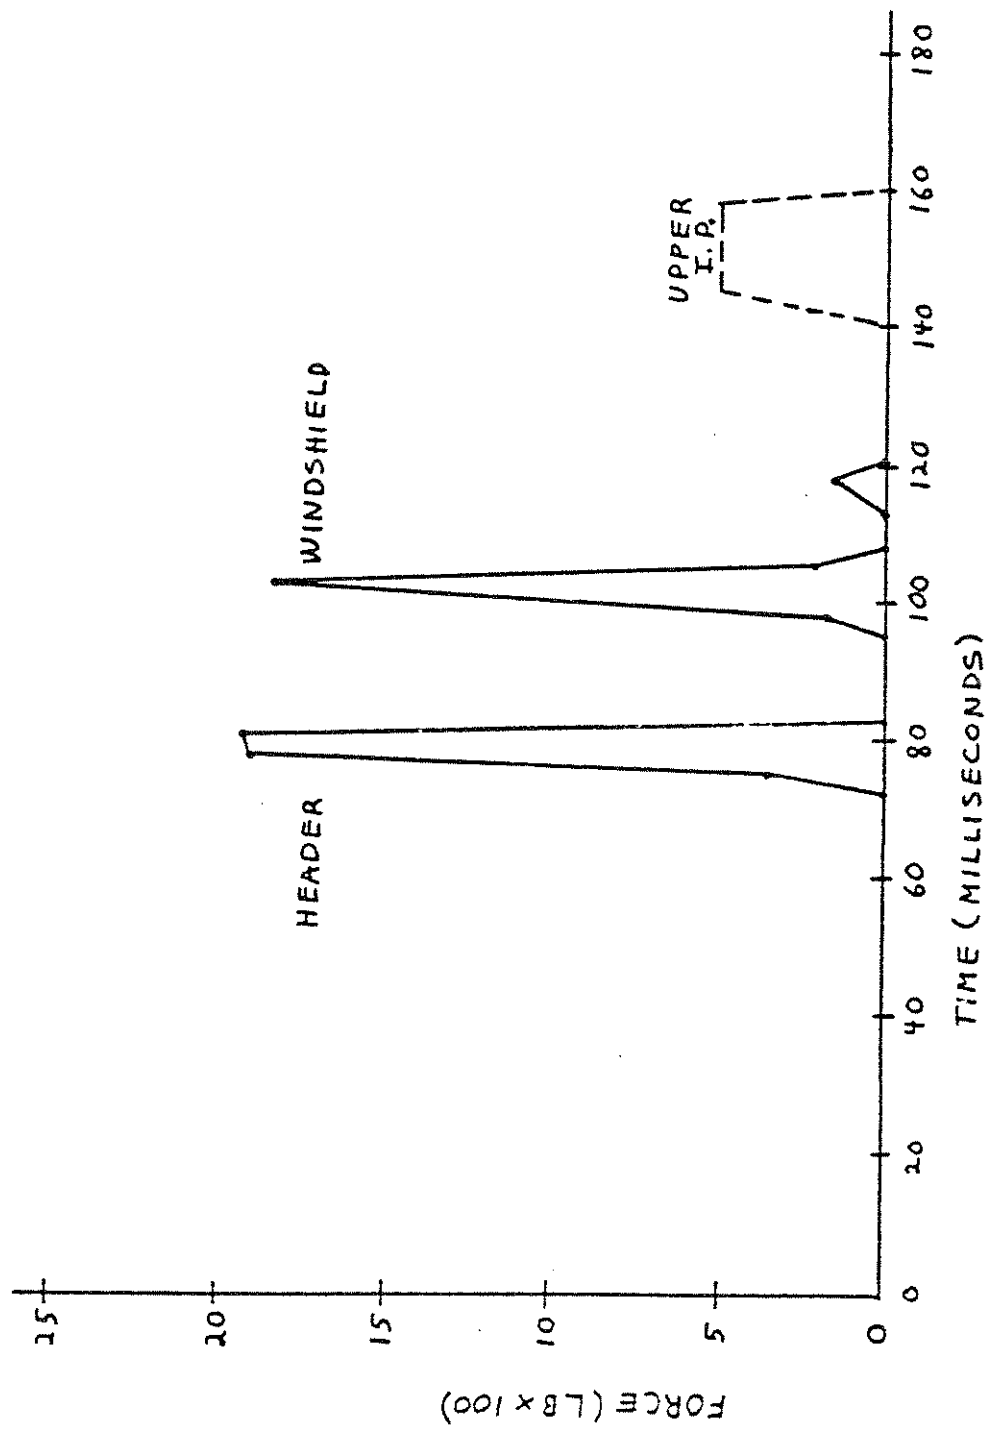
Figure 12. Force on Head Due to Interior Contacts (Case No. 9).

Figures 12-15 show some of the dynamic output results produced by the simulation. Figure 12 shows the sequence of interactions between the head and, successively, the header, windshield, and upper instrument panel. Figure 13 shows the chest and abdomen interactions with the steering wheel/column. Interaction between the lower part of the steering wheel rim and the abdomen leads the chest/column contact by about 10 milliseconds. Substantial normal forces are generated on both the femur (at the knee) and the tibia (just below the knee) during their contact with the lower instrument panel as shown in Figure 14. Because of the two-dimensional nature of the MVMA-2D occupant motion simulation, the numbers shown represent the sum of the loadings to both legs. Vehicle/occupant interactions observed as actual contact points in the crashed vehicle indicate that this assumption is reasonable. Head and chest accelerations are shown in Figure 15.

This large, 35 year old male sustained significant head impacts against the header and windshield. The force levels of 1800-1900 lbs. associated with these impacts would not be expected to cause frontal bone skull fractures although they approach the lower limits of frontal fracture tolerance for flat impact surfaces. Similarly, the head accelerations associated with these two impacts are moderately severe (peaks near 120 G's). Additional head acceleration peaks around 80 G's are also present, and the entire head acceleration-time history (Figure 15) is characterized by significant time durations as well as acceleration magnitudes. This subject was concussed for 2-3 minutes.

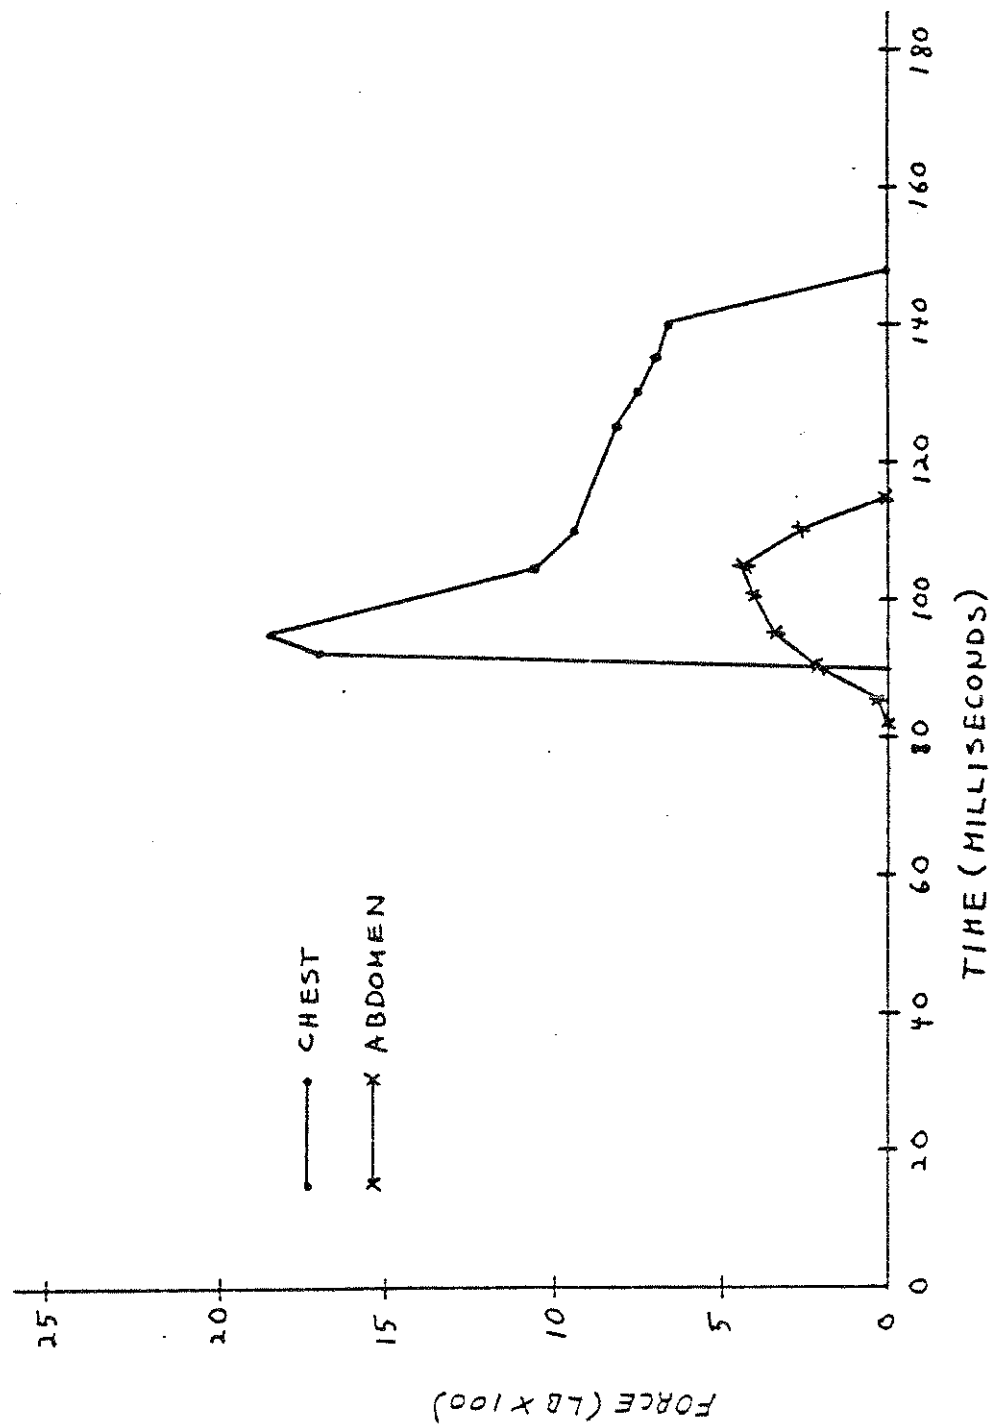
Figure 13. Force on Chest and Abdomen from Steering Wheel (Case No. 9).

The size and position of the subject and the vehicle interior geometry combined to produce a uniform contact of the chest squarely with the steering wheel. Although uniform, the loading was severe enough to fracture the sternum. The predicted load peak was approximately 2000 lbs. which is similar in magnitude to those produced by experimental studies on chest impact with cadavers. The chest accelerations associated with the impact were less than 50 G.

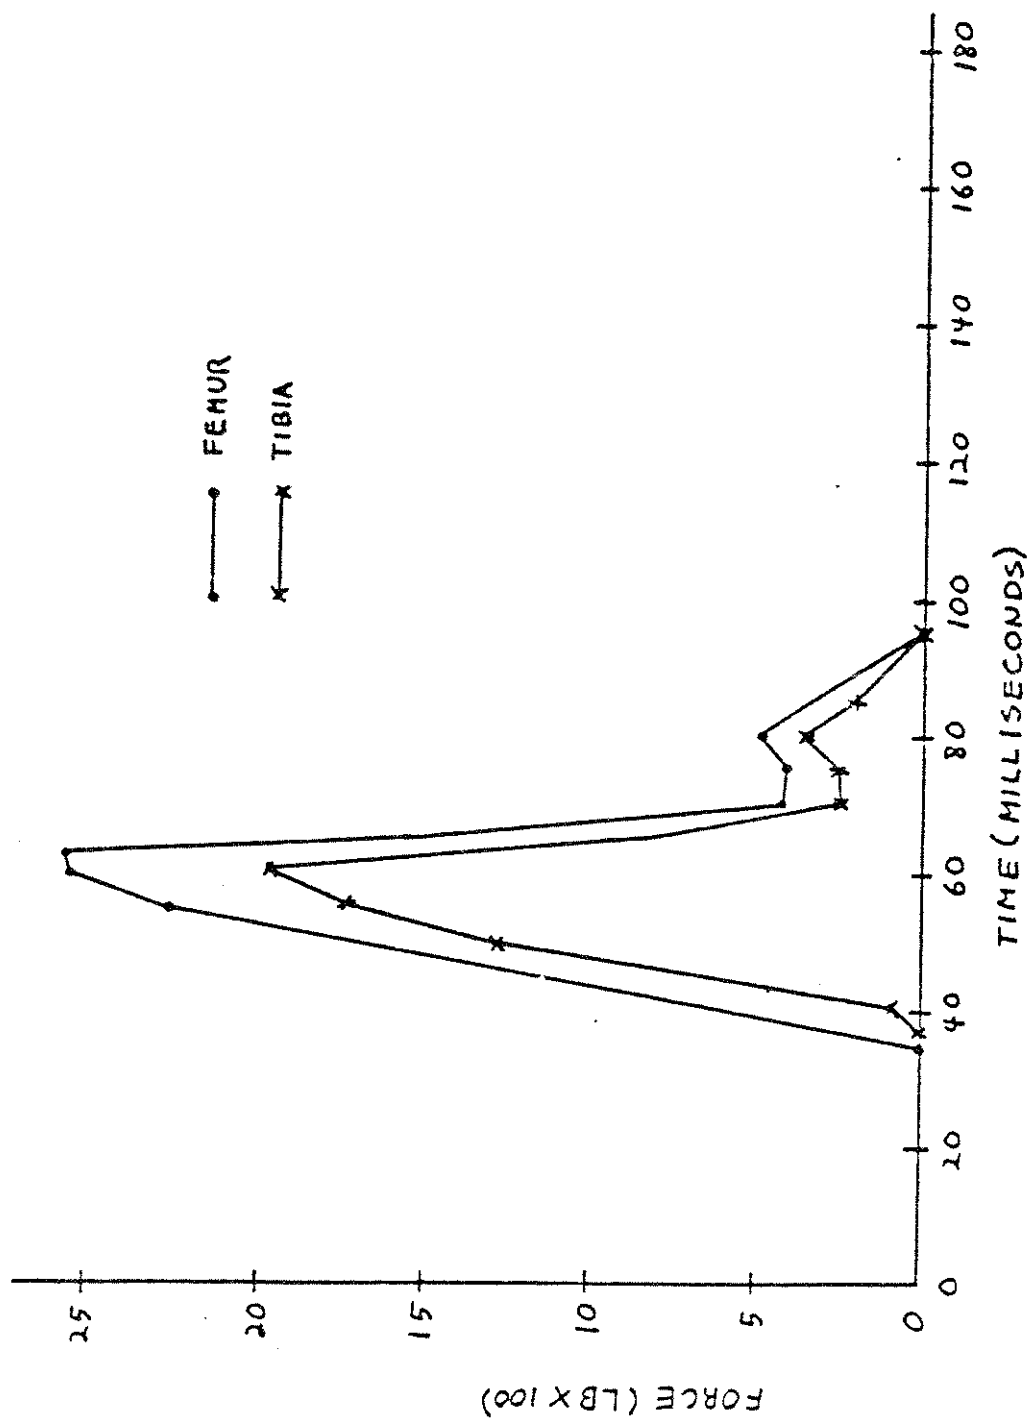
Figure 14. Force on Knee and Tibia from Instrument Panel (Case No. 9).

The contact of the subject's legs with the instrument panel produced an average force of 1300 lbs. in each femur and 1000 lbs. into each lower leg. This resulted in a total femur load of approximately 2300 lbs. in each leg as the lower leg force would be transmitted by shear to the upper leg. The lower leg load was close to tolerable values for knee joint ligamentous damage in cadavers. The subject was tall and had robust legs. Neither the average lower leg loads of 1000 lbs. nor the total femur loads of 2300 lbs. were likely near the tolerance of this subject.

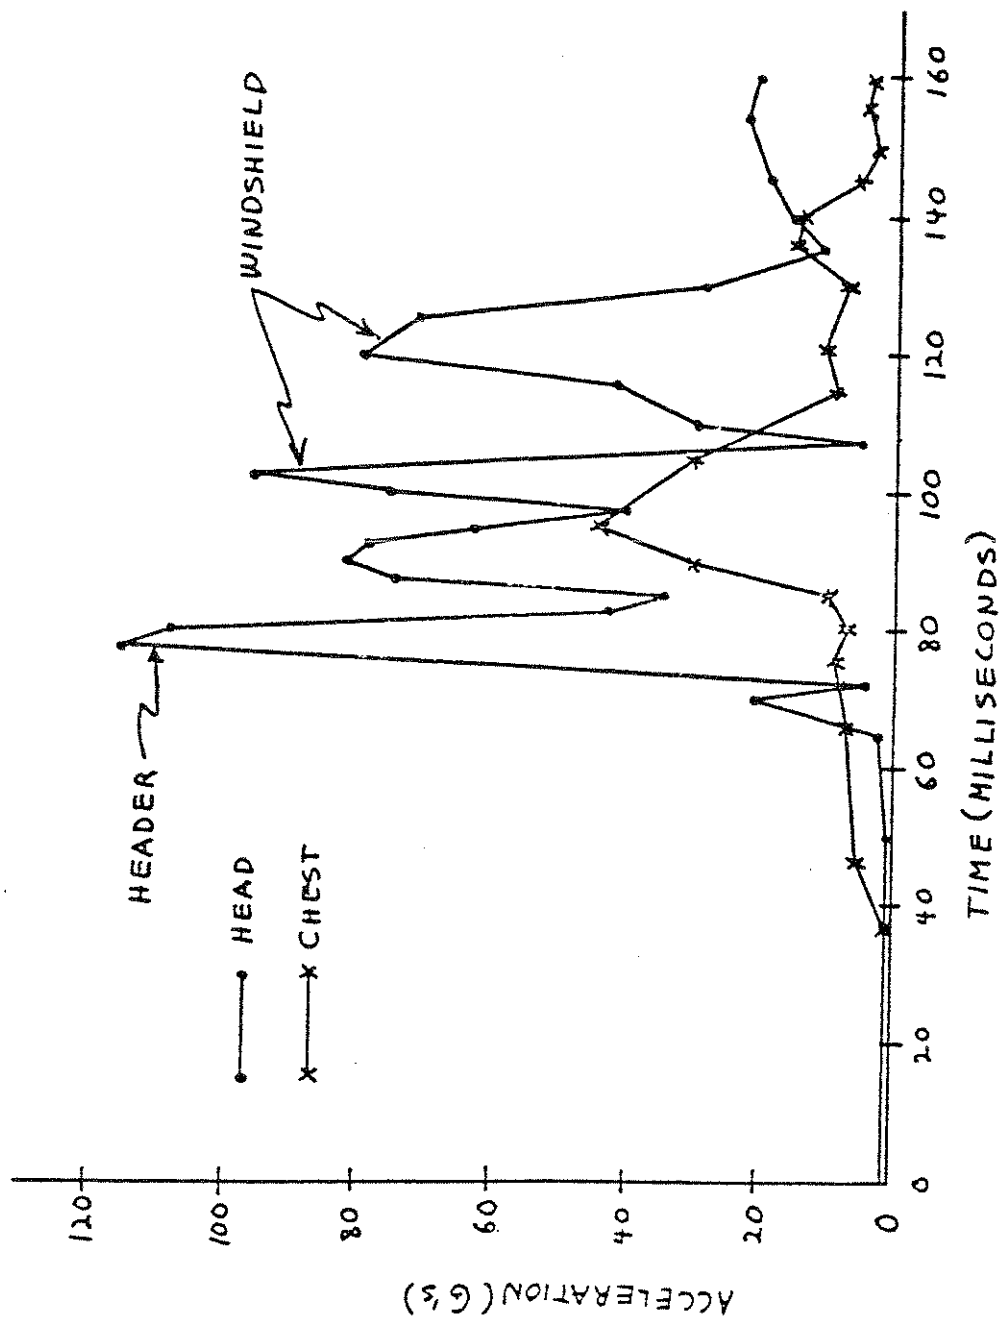
Figure 15. Head and Chest Accelerations (Case No. 9).

For the most part the peaks correspond with the peak force loadings shown in the previous figures.

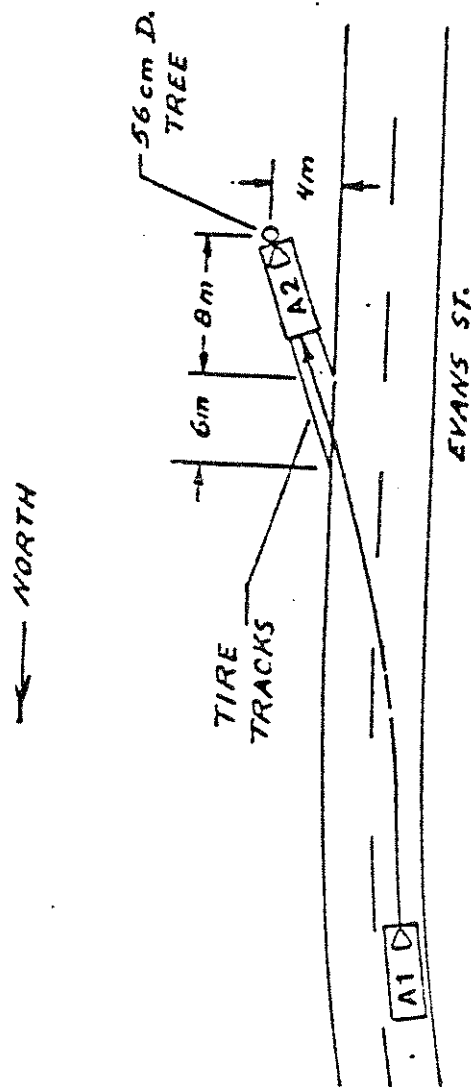
Figure 16. Schematic of Accident Scene (Case No. 10).

In this case a 1977 Oldsmobile Cutlass S was forced off the roadway and struck a 56 cm diameter tree directly head-on. Frontal crush of the car was 93 cm. Figure 16 is a schematic of the accident showing the well-defined vehicle motions. Figure 17 shows the severe and almost perfectly symmetric damage sustained by the vehicle.

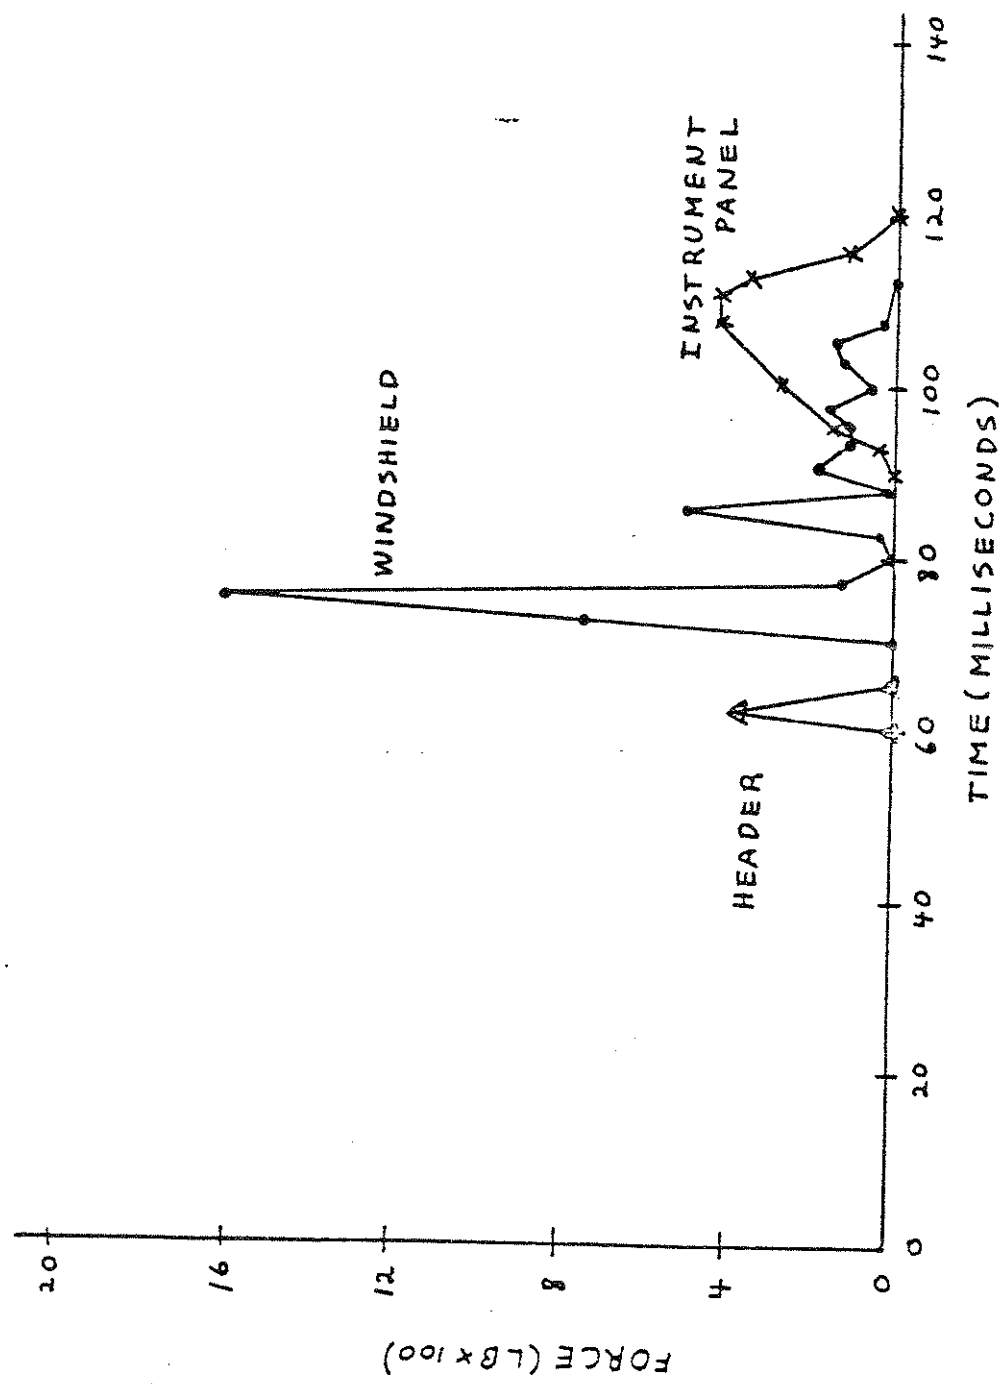
Figure 24. Force on Head due to Interior Contacts (Case No. 10).

Figures 24-27 show some of the dynamic output results produced by the simulation. Figure 24 shows the predicted force loadings applied to the head. The three primary interactions are with the header, windshield, and instrument panel. Interactions of the chest and abdomen with the steering

This case involves a more severe frontal crash than in Case 9 (28.6 mph versus 22.9 mph) with an older, smaller male driver (50 years old) of a larger car. The contact of the head with the header was not as severe as the windshield contact, which produced a peak of 1600 lbs.--well below frontal bone fracture tolerance. The head acceleration associated with the windshield contact was higher than that of Case 9 (150 G peak) but with a lesser duration. Similar longer duration acceleration peaks around 80 G occurred late in both crashes. The subject was only briefly unconscious.

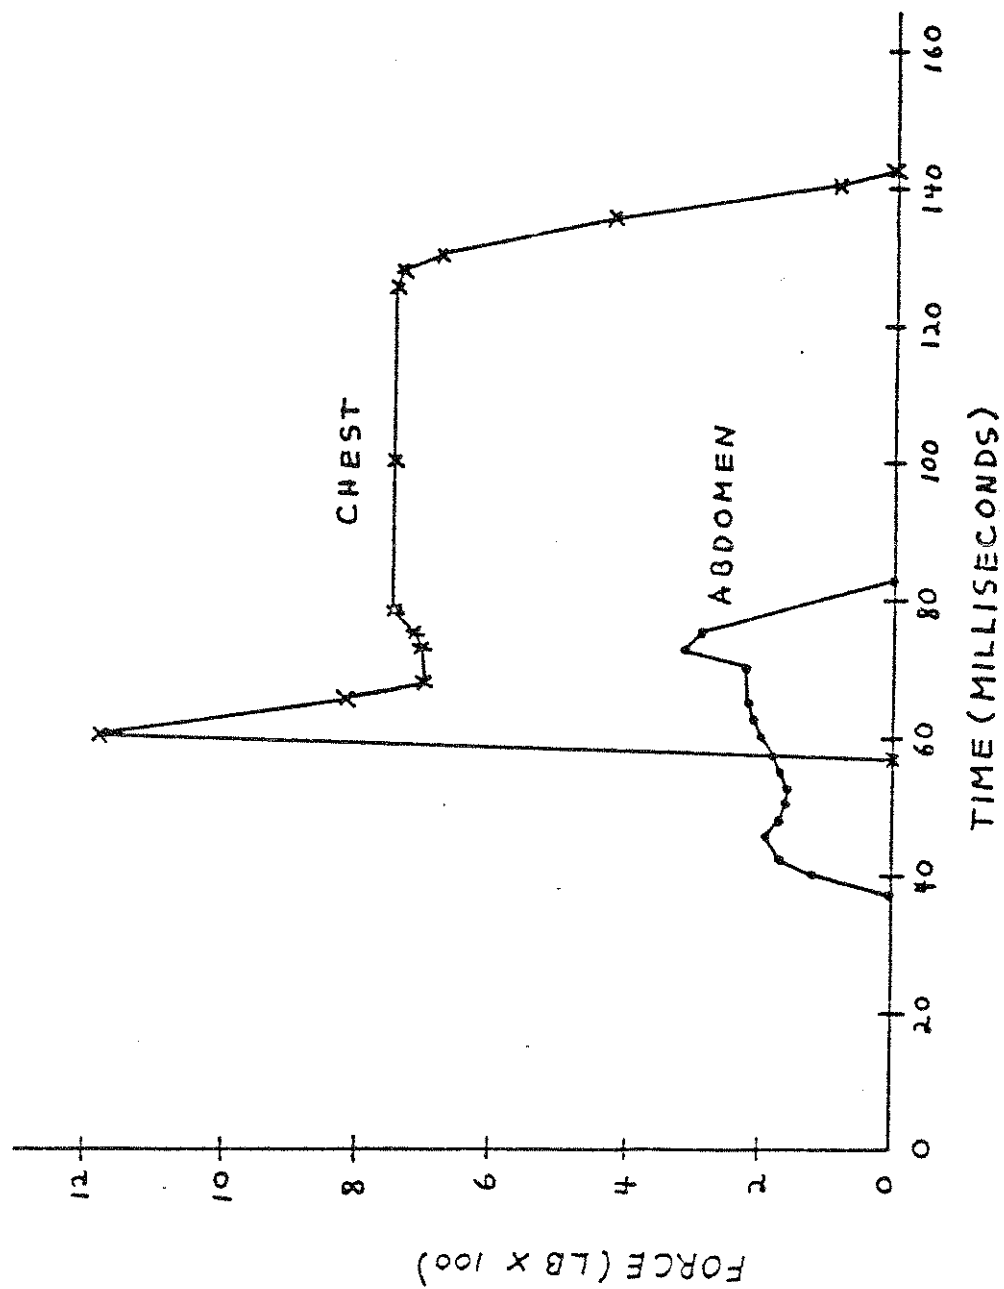
Figure 25. Force on Chest and Abdomen from Steering Wheel (Case No. 10).

wheel/column are shown in Figure 25. The abdomen is in contact for approximately 20 ms before the rib cage becomes substantially involved in the dynamics. The tibia and femur loads shown in Figure 26 show the considerable force which was likely transmitted to the acetabulum. Figure 27 shows head and chest accelerations which are, as happened in Case No. 9, well correlated with the phasing of the loadings shown in the previous figures. It should be noted that the ~~G~~-loading to the head due to the header contact is relatively low. This is a case where small changes in input data could dramatically change the simulation. If the occupant sat 1/2 inch lower, the contact would not occur. If he were 1/2 inch higher, the size of the force spike would likely be larger than that for the windshield. The effect of vehicle pitch during the tree impact was not investigated due to the limited nature of the project and could also be a major factor in the relative position of the head with respect to the vehicle in the timing of this important contact.

The contact of the subject's chest with the steering wheel was not as uniform or aligned as in Case 9 due to configurational differences in the vehicle interior and the subject positioning. A peak chest load of 1200 lbs. was produced. The fractures of the 8th and 9th ribs on the left side may have been due to the interaction of the bottom half of the steering wheel as shown in Figure 21. The age of the subject may also have had an influence on the production of skeletal damage at the lower load of 1200 lbs. Despite the lower load, the peak chest accelerations were slightly higher (55 G) than in Case 9.

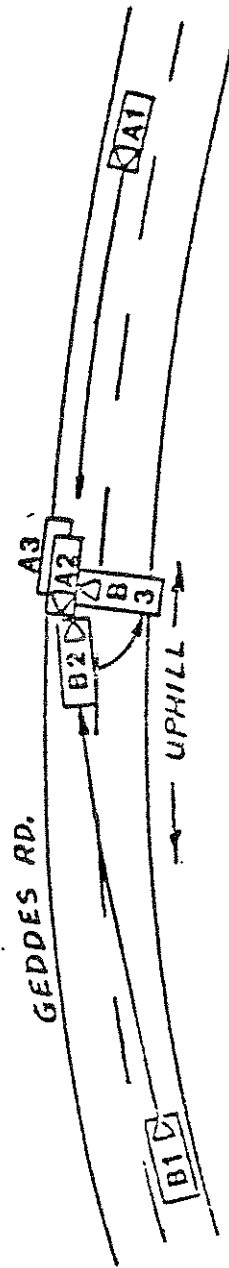
Figure 28. Schematic of Accident Scene (Case No. 13).

In this case a 1980 Volkswagen Rabbit was driving on a two-lane road. A Chevrolet Blazer crossed the centerline on an icy turn. The impact energy transfer was nearly "head-on" for the Rabbit. Figure 28 is a schematic of the accident scene. Figure 29 shows the damage to the vehicle.

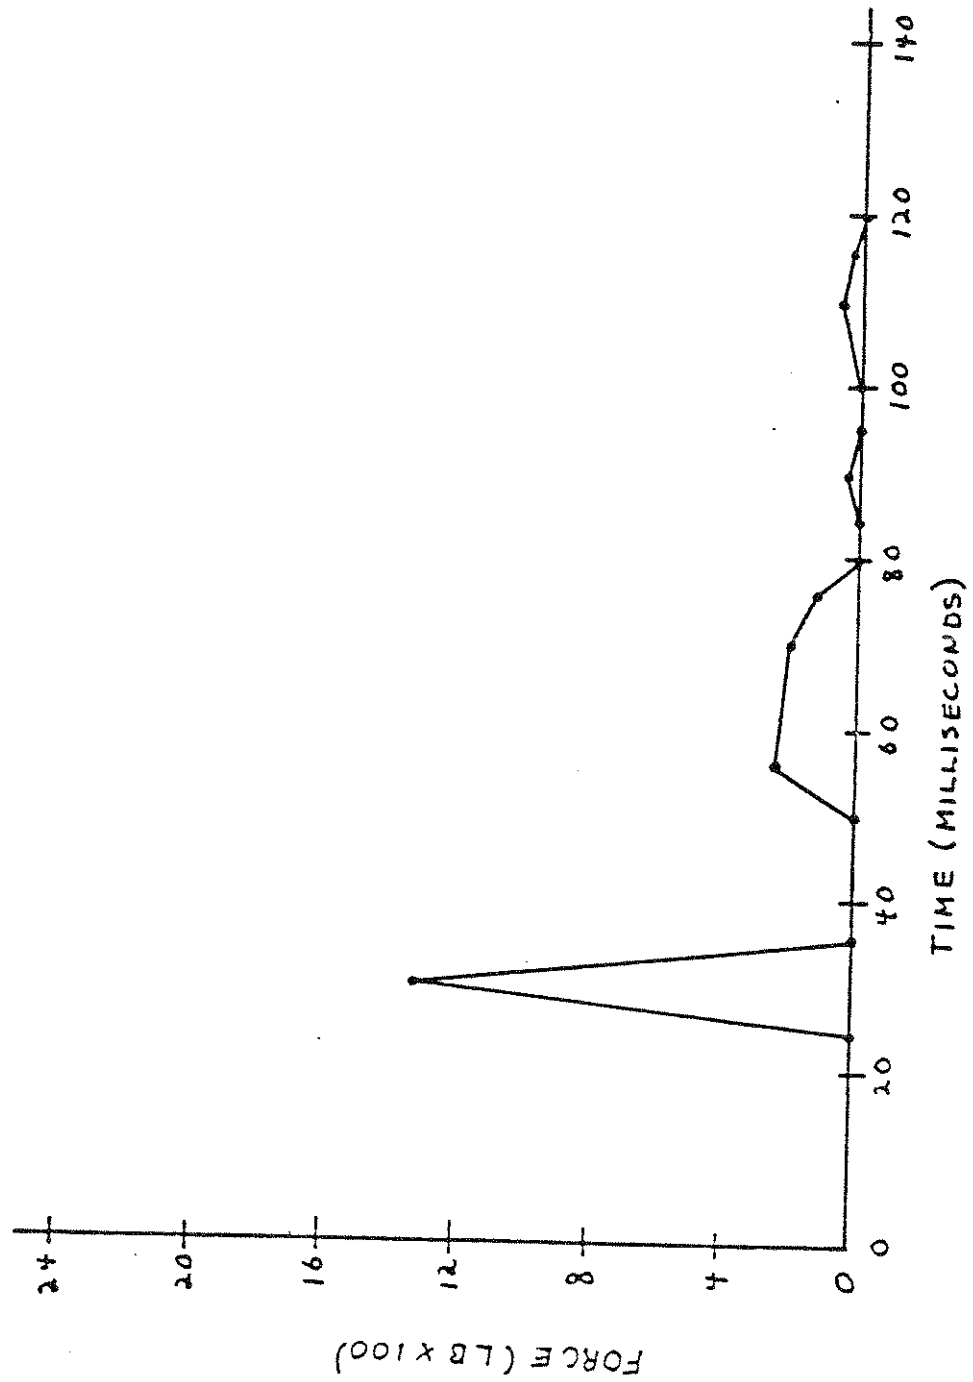
Figure 36. Force on Forearm from Steering Wheel (Case No. 13).

Figures 36-39 show some of the dynamic output results produced by the simulations. Interactions between the forearm and the steering wheel are shown in Figure 36. Although the magnitude of the initial spike is probably unrealistic from a human response point of view, the ability to feed force and energy into the body through this part in the linkage in a relatively continuous manner has been demonstrated. Refinement of the force-deflection curve for the steering column, which was used for this simulation, to reflect a softer material property for wheel rim deformation, would probably solve much of the problem. Similarly, the properties of elbow and shoulder joints could be refined, to include muscle tension effects and the mobility of the shoulder girdle. No well-researched data have been developed to this point in time for definition of shoulder girdle mobility. Figure 37 shows the major restraint effect on the chest due to the upper torso belt. Figure 38 shows the forces on the tibia due to contact with the bolster. This force is transmitted into the knee joints as a shear force. Within the limited scope of this project it was not possible to explore the intrusion of the knee bolster into the occupant compartment. This intrusion could have had a marked effect on the results. Figure 39 is a plot of head and chest accelerations. The peak head accelerations follow the peak chest accelerations which appear to be directly related to the application of the belt forces. This phasing relation is related to the pitching down of the head with respect to the upper torso. No evidence of contact of the head with the vehicle is evident.

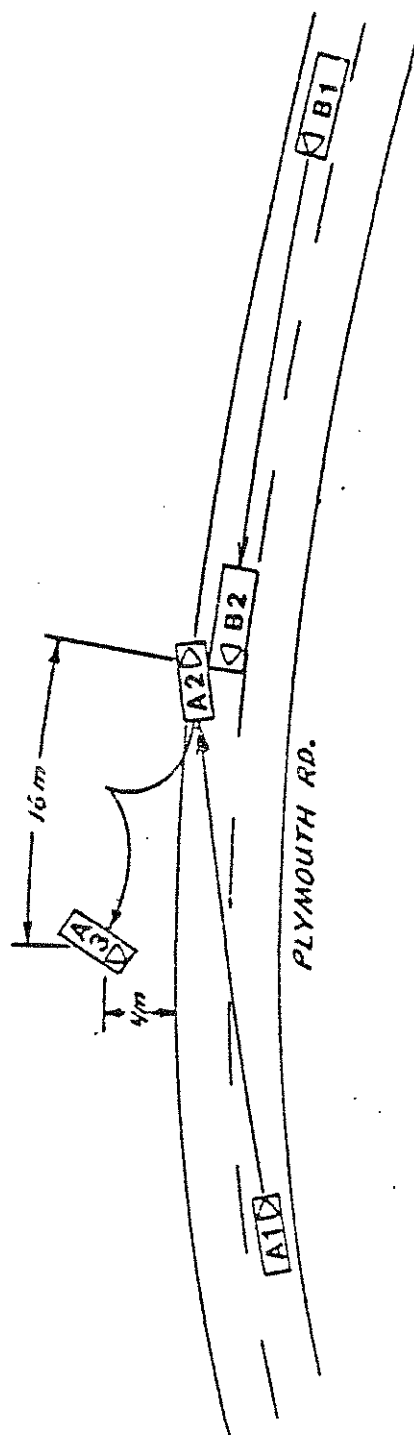
Figure 40. Schematic of Accident Scene (Case No. 14)

In this case a 1980 Chevrolet Chevette was struck in the side by a C/20 Chevy Van. Intrusion was extensive on the passenger's side. The female driver of the Chevette was wearing a lap-shoulder belt and sustained minimal injuries. A schematic of the accident scene is shown in Figure 40. Damage to the Chevette is shown in Figure 41. Although there was a spin by the subject vehicle, it appeared that the primary force vector was

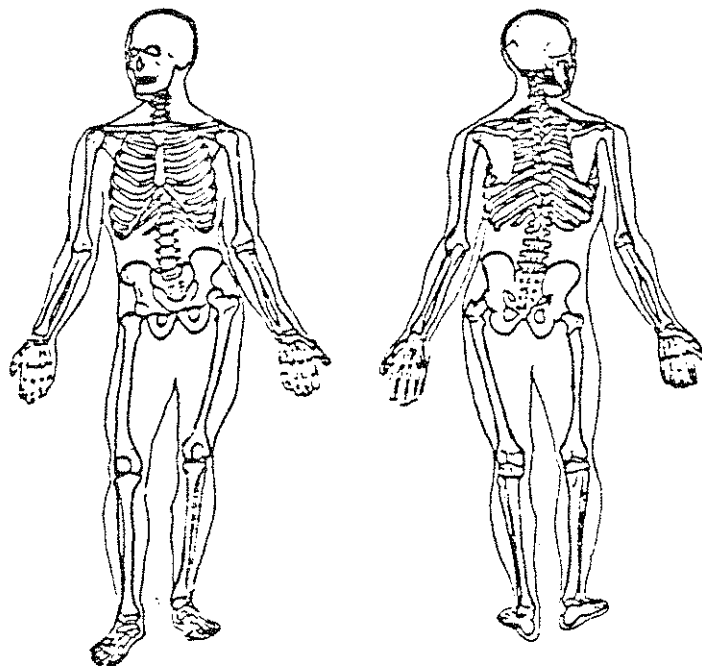
Figure 42. Occupant Injuries (Case No. 14).

1. Lac. Rt. Frontal Scalp
2. Cont. Rt. Proximal Anterior and Medial Thigh
3. Lac. Posterior Rt. Shoulder
4. Cont. Rt. Calf

The driver sustained only minimal injuries as illustrated in Figure 42. These were apparently due to contacts with the right door, T-bar shift lever, and seat belt buckle.

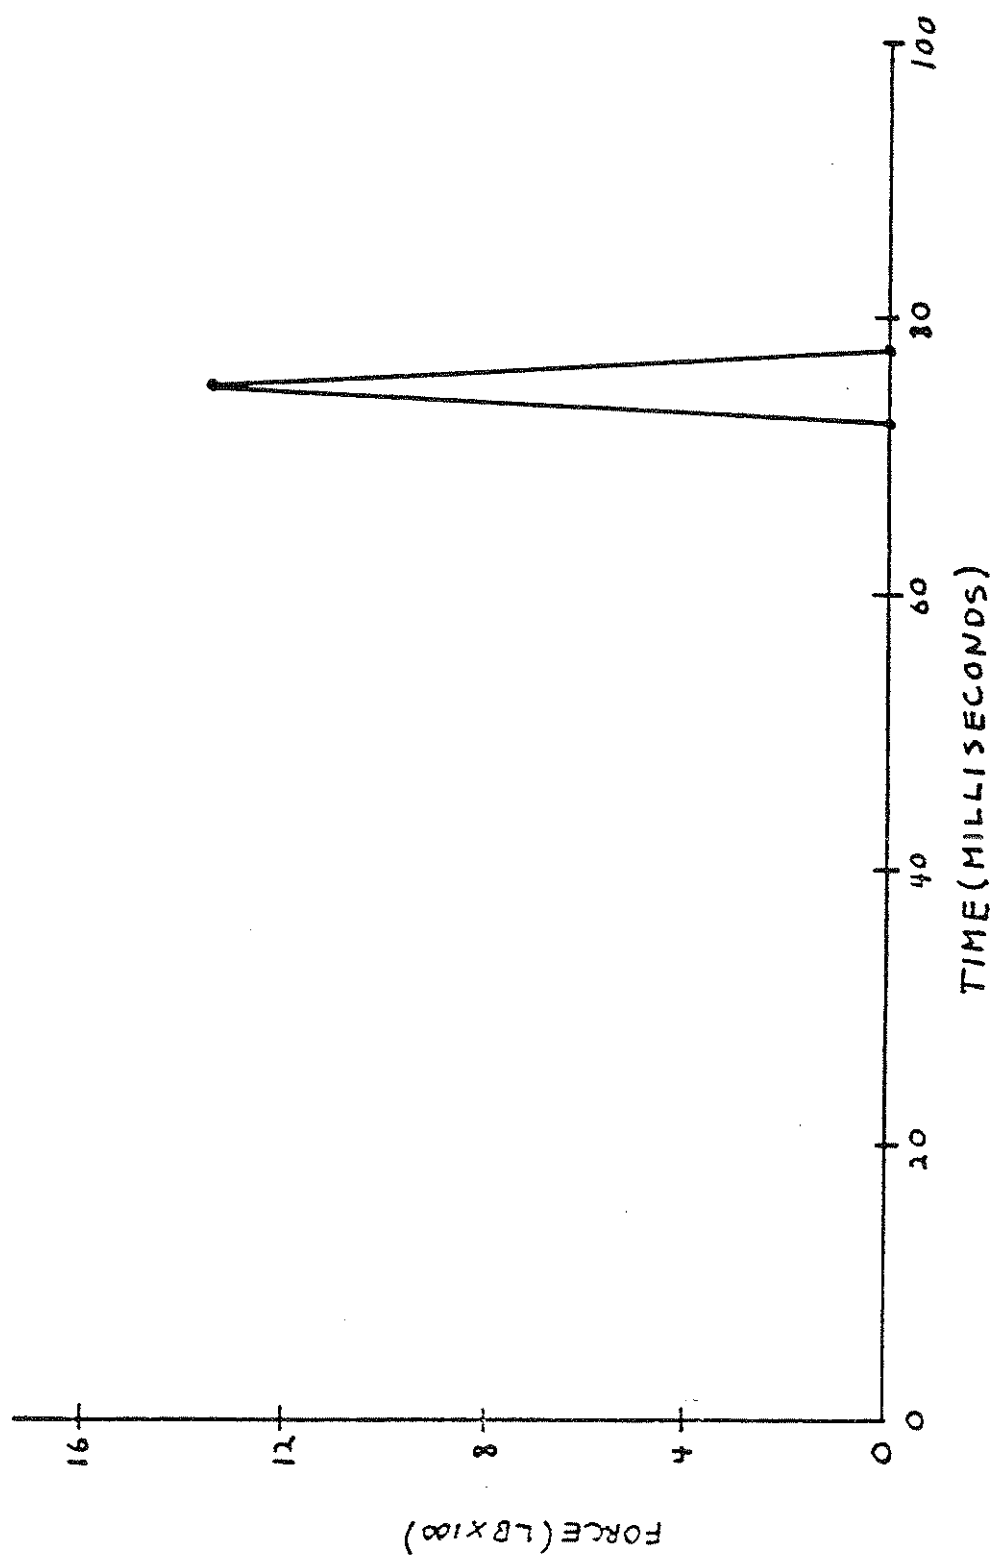
Figures 48-54 show some of the dynamic output results produced by the simulations. Figure 48 shows the force on the head produced during the window contact. The restraining effect of the belt forces is shown in Figure 49. The effect of the belts is to prevent the lower torso and extremities from completely riding over the transmission housing. The arm/shoulder interaction with the door is shown in Figure 50. Computer exercises using either more or less intrusion of the door resulted in higher or lower to no force of interaction. Figure 51 documents the interaction of the thighs and upper legs at the hip with the transmission housing. The location of the 3-point belt stalk by the housing and the minor injury suffered by the driver most likely resulted from this interaction. The interaction between the leg and shift lever is shown in Figure 52. It also occurs early in the dynamic event. Figures 53 and 54 show the lateral and vertical accelerations experienced by the dynamic linkage. In many cases the peaks correlate well with observed kinematic or dynamic events. Chest accelerations shift from lateral (40-60 milliseconds) to vertical (60-80 milliseconds) as the belt system and shift housing causes the torso to pitch toward the side. A clean spike shows up in the head lateral acceleration which correlates well with the interaction with the window. Head vertical accelerations appear to be larger than would be expected for a human. This could probably be corrected by including better data (if it

Figure 48. Force on Head from Window (Case No. 14)

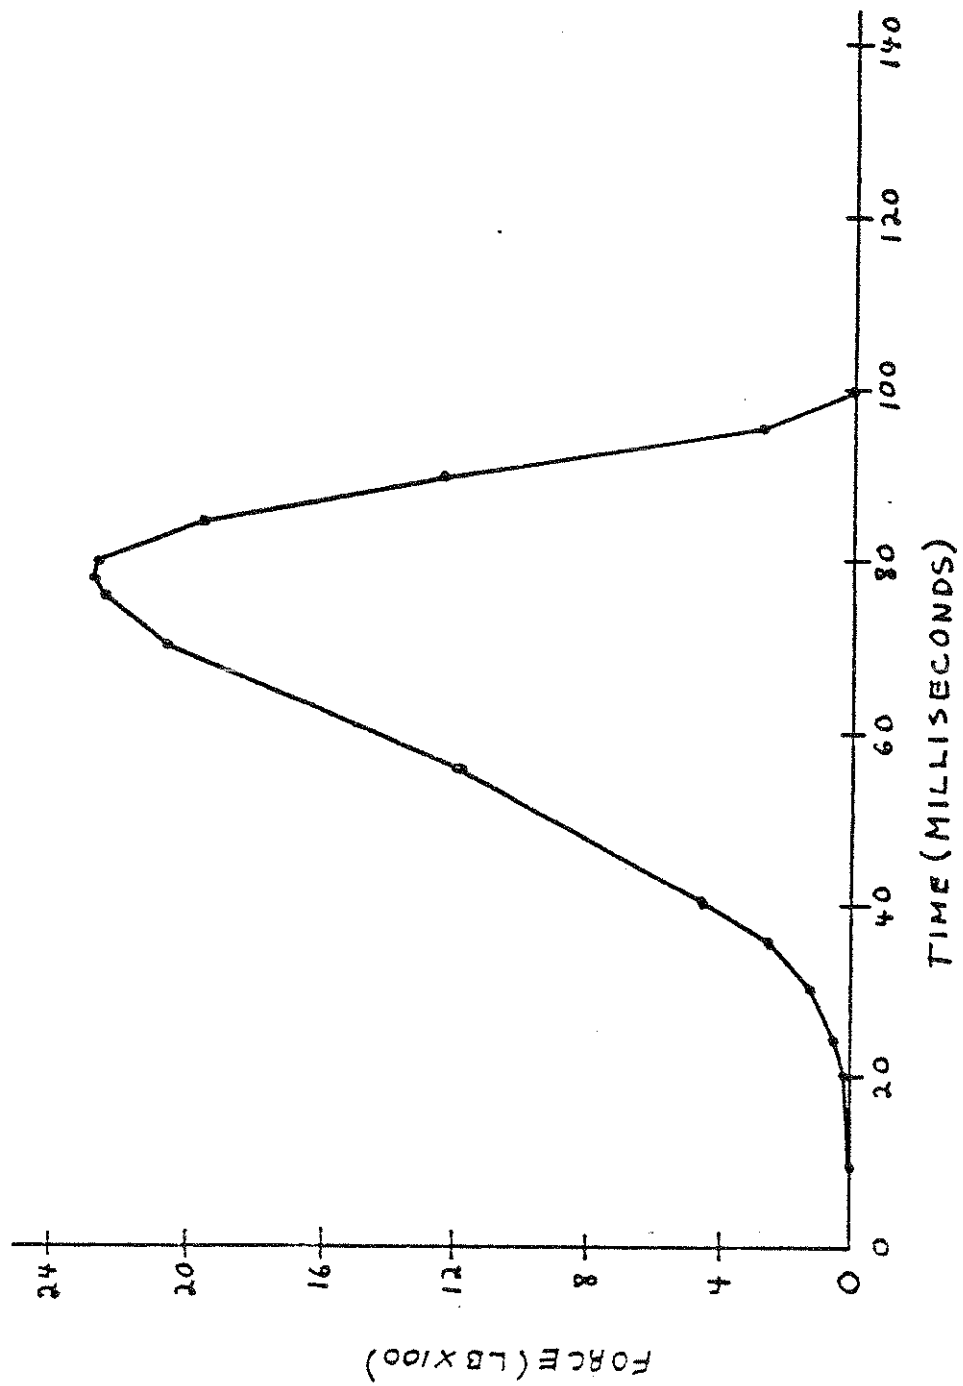
Figure 49. Belt Force (Case No. 14)

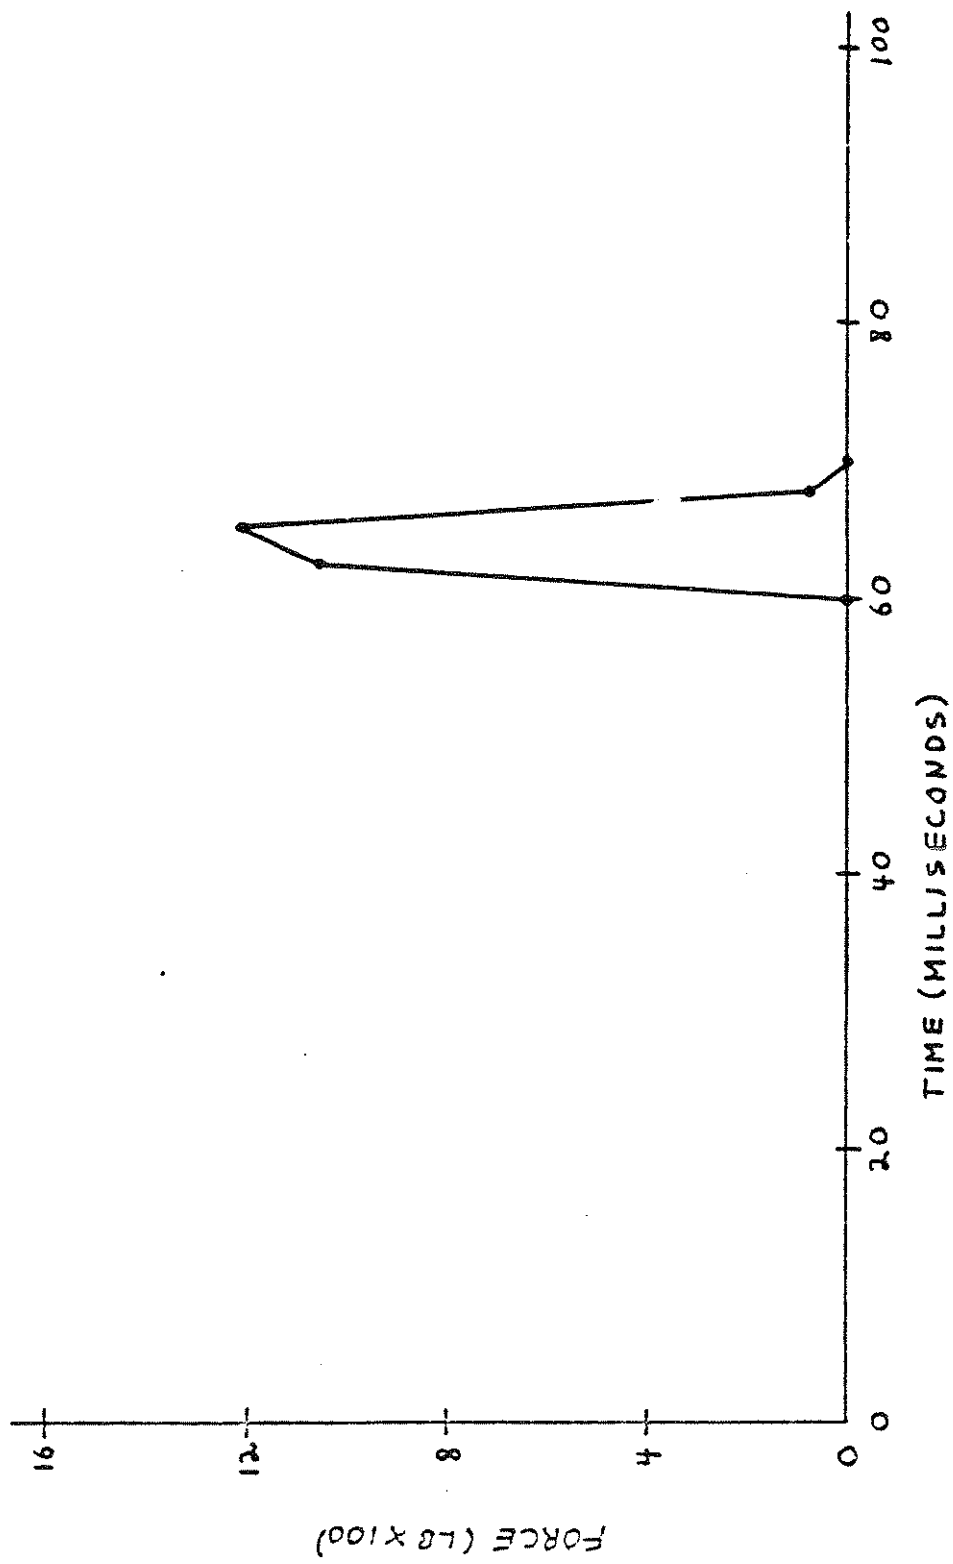
Figure 50. Force on Arm/Shoulder from Door (Case No. 14).

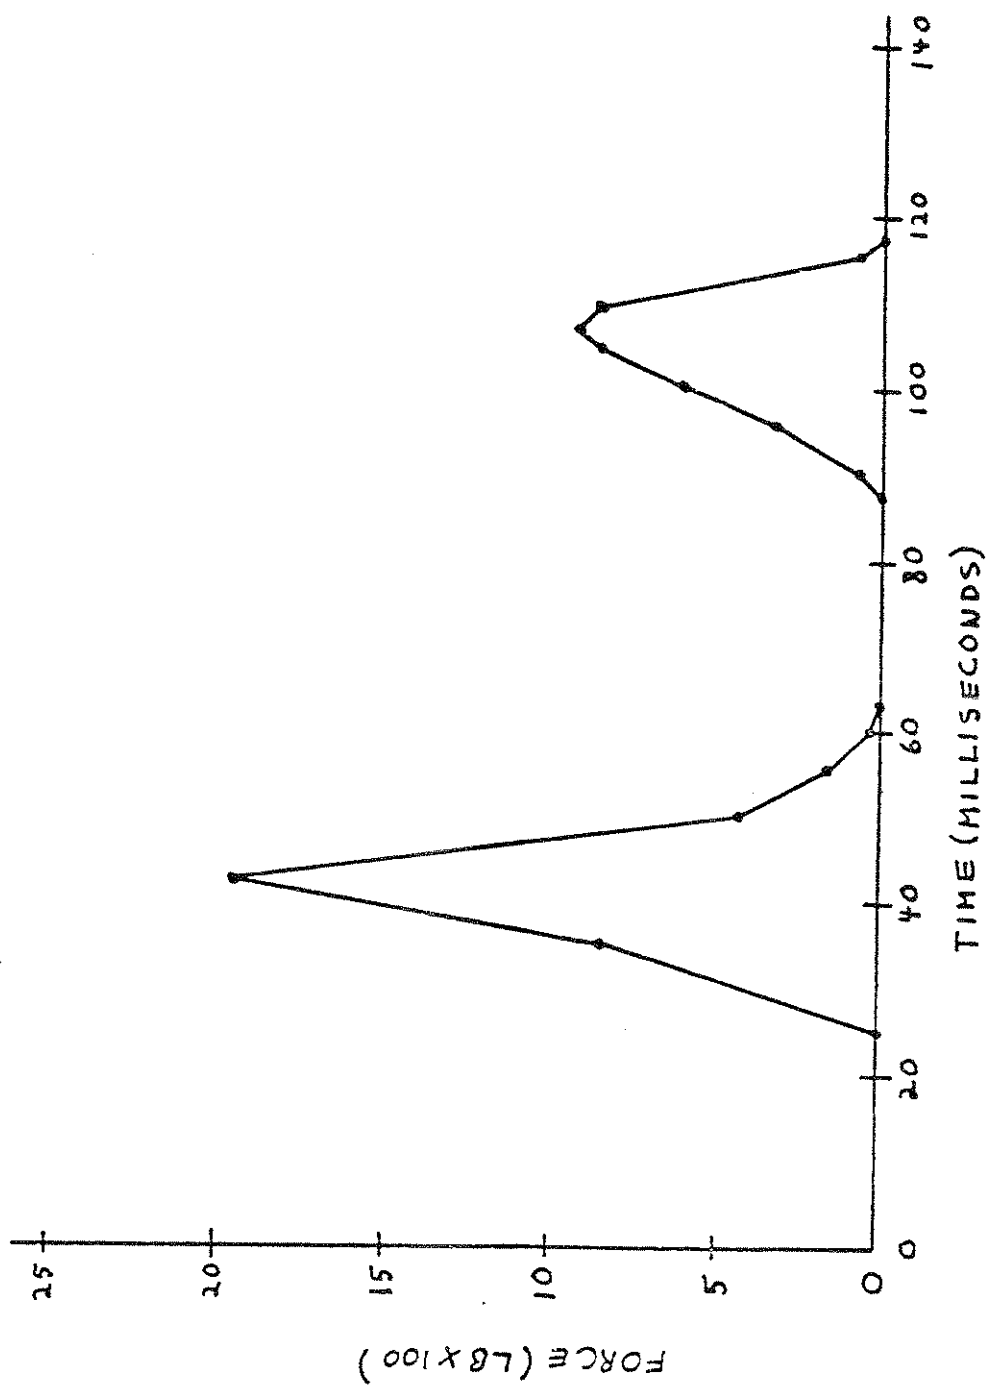
Figure 51. Force on Right Upper Leg from Transmission Housing (Case No. 14)

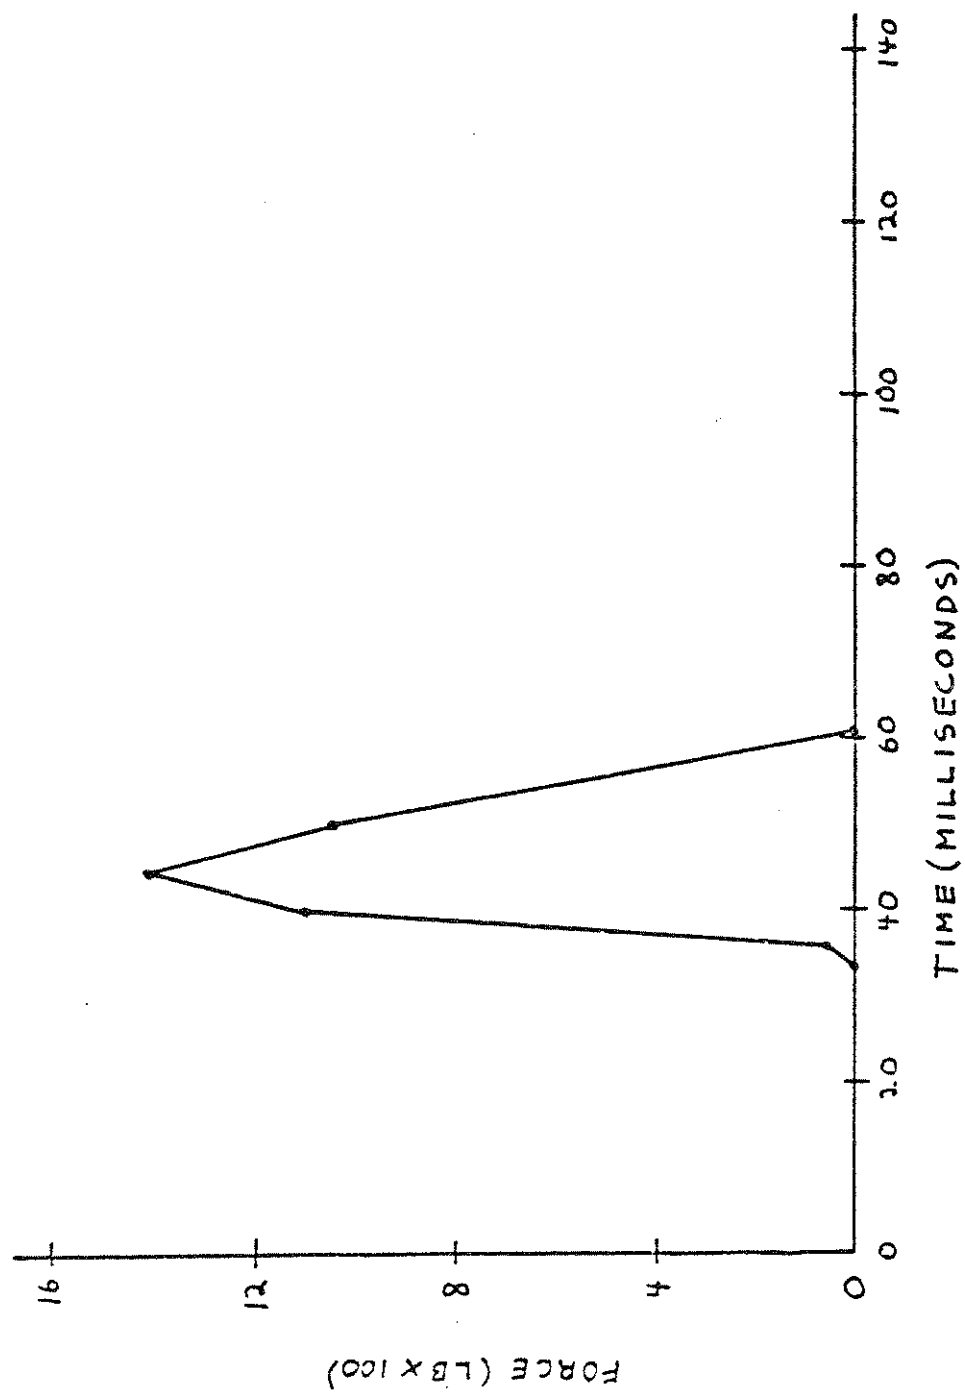
Figure 52. Force on Leg due to Shift Lever (Case No. 14).
