UMTRI-83-3

Biomechanical Accident  
Investigation Methodology

Final Report  
February 1983

Prepared for  
Motor Vehicle Manufacturers Association  
320 New Center Building  
Detroit, Michigan 48202

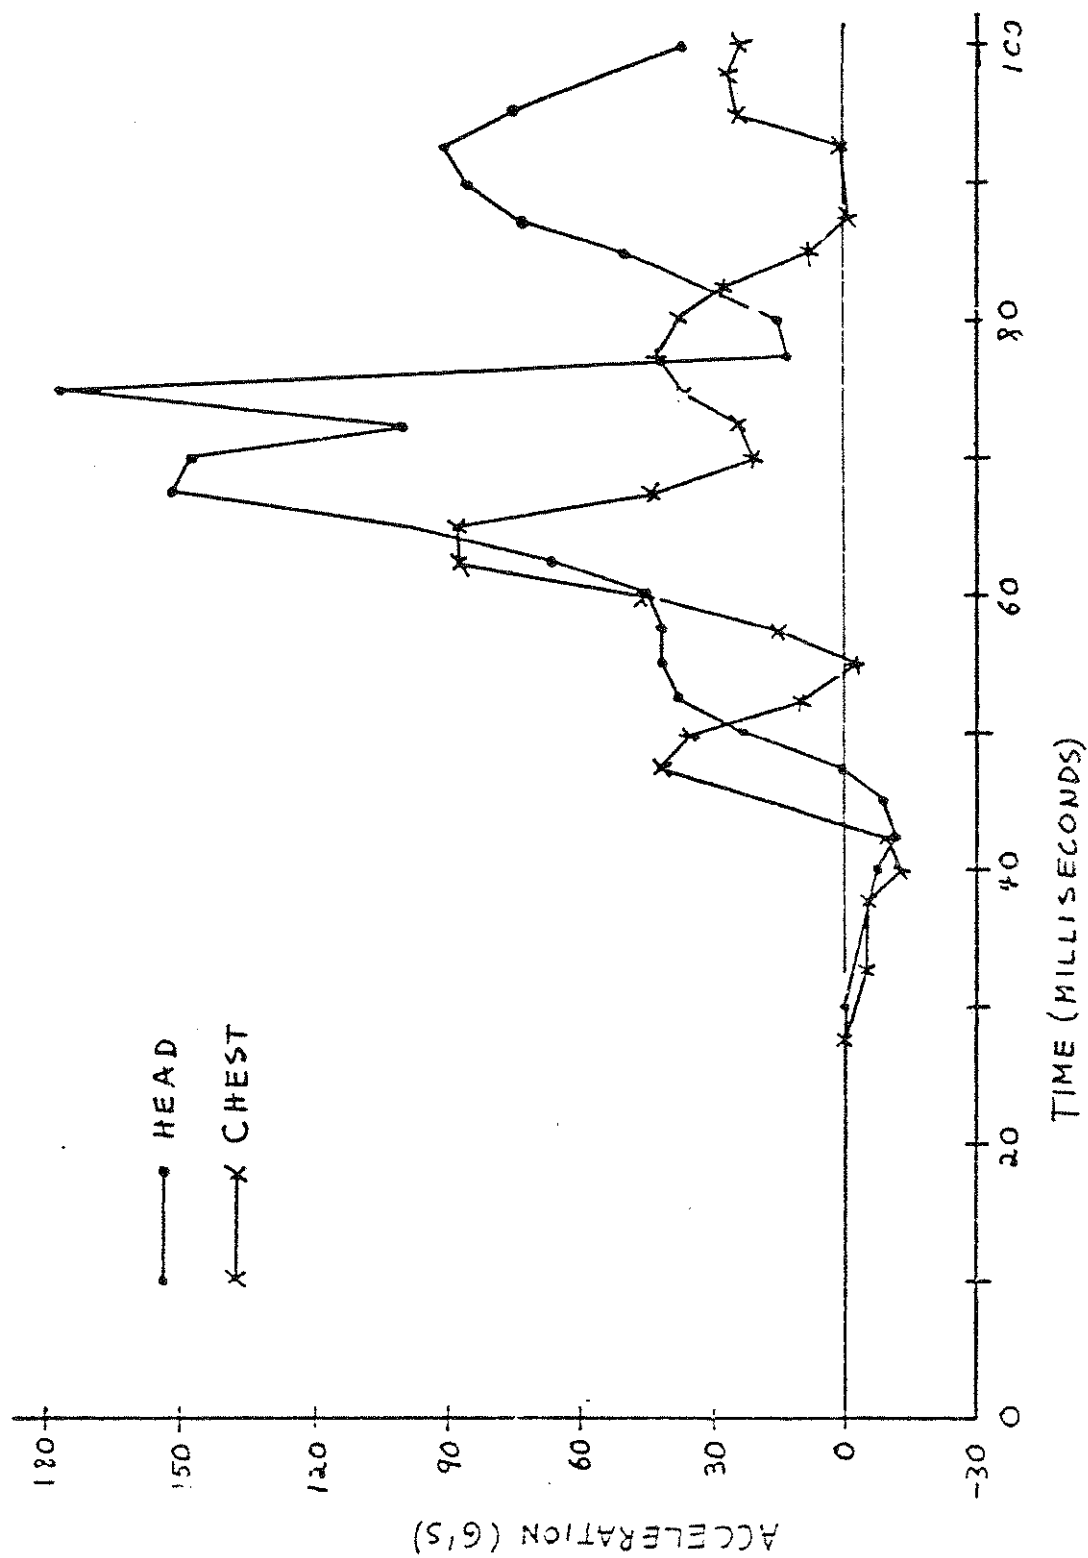
Figure 53. Head and Chest Vertical Accelerations (Case No. 14).

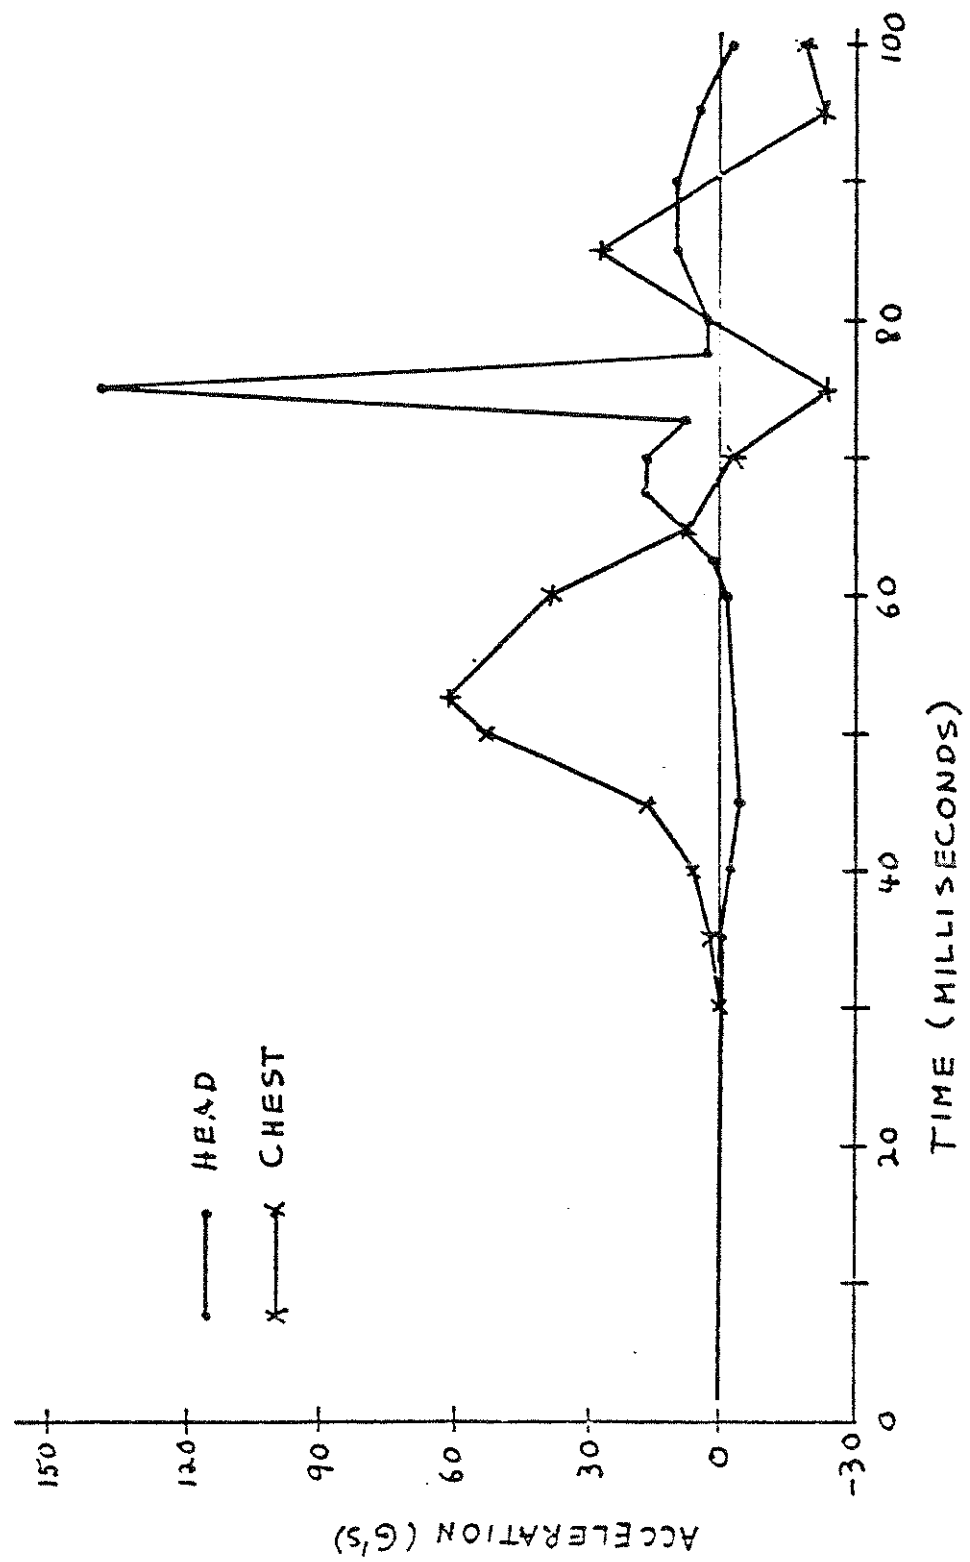
Figure 54. Head and Chest Lateral Accelerations (Case No. 14).
